September 23, 2022

Eastern Oregon University
Attn: John Garlitz, Director of Facilities & Planning
One University Boulevard
La Grande, Oregon 97850

**Re: Supplemental Asbestos Containing Materials Inspection
Trustee's Board Room – Inlow Hall, Eastern Oregon University Campus**

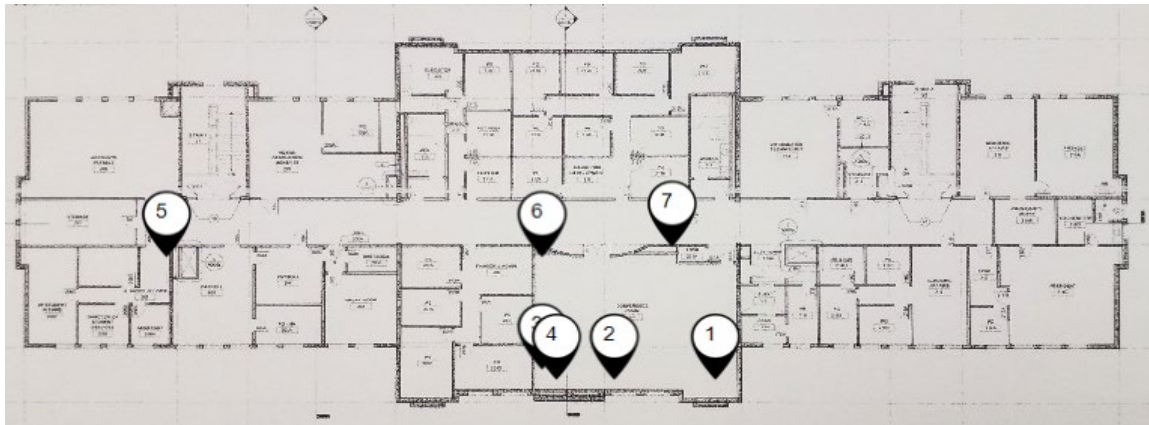
Figure 2: ACM Sample Locations

Laboratory analysis identified all samples collected as non-detect for asbestos. See Figures 2 for ACM sample locations. See Attachment C for Laboratory Results.

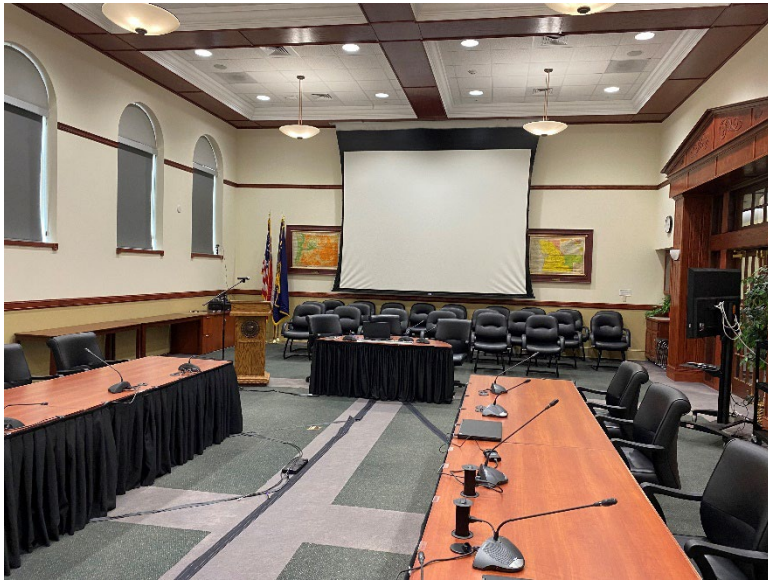
Fulcrum completed a limited ACM inspection of the Trustee's Board Room.

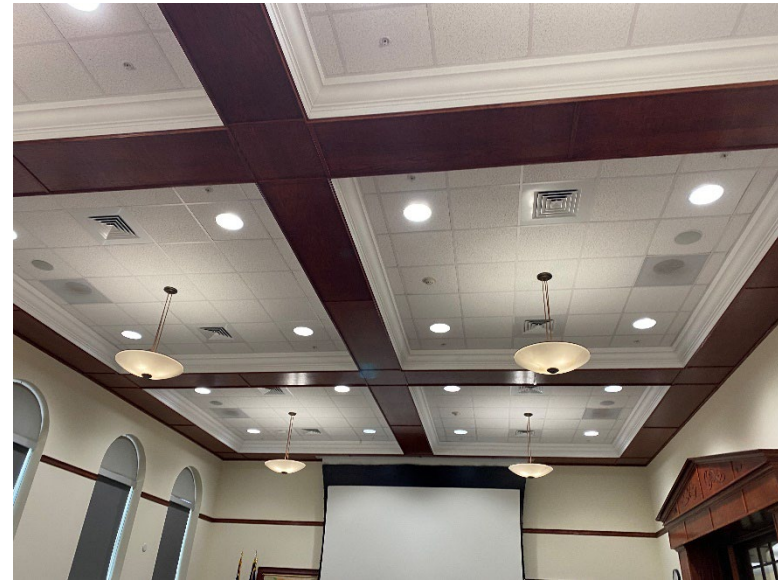
The ceiling is comprised of 2-foot by 2-foot suspended ceiling tile.

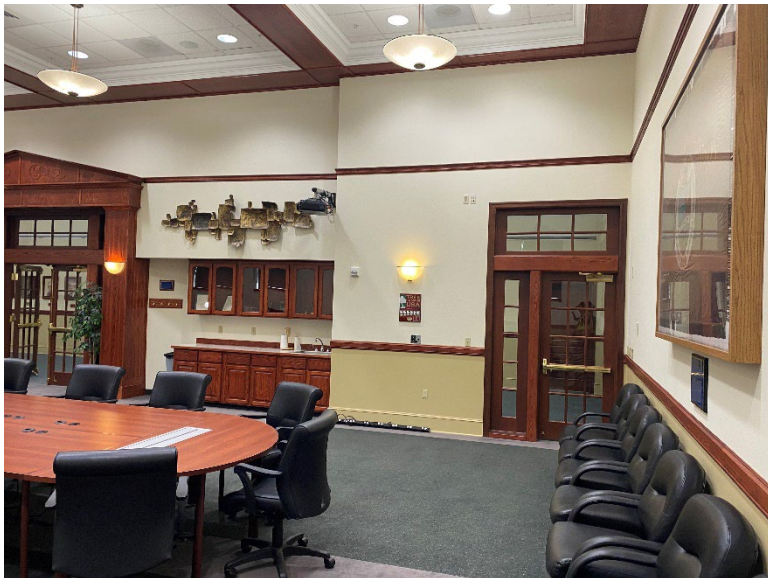
Walls are comprised of tan gypsum wallboard.

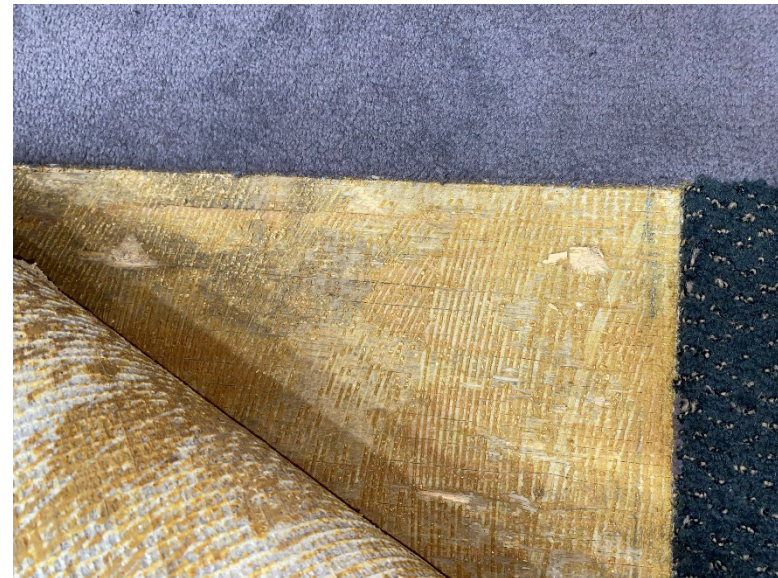
Flooring is comprised of gray and green carpet with tan adhesive on plywood underlayment.

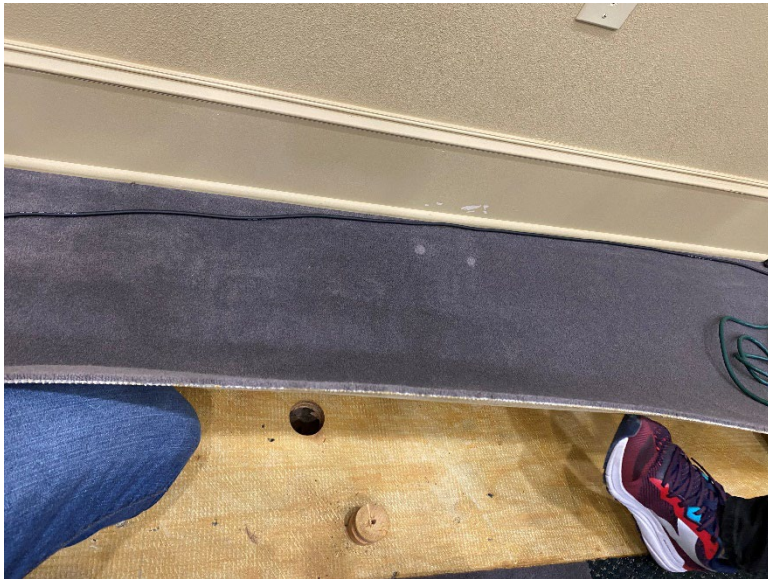
Fulcrum completed drilling of the plywood subfloor.

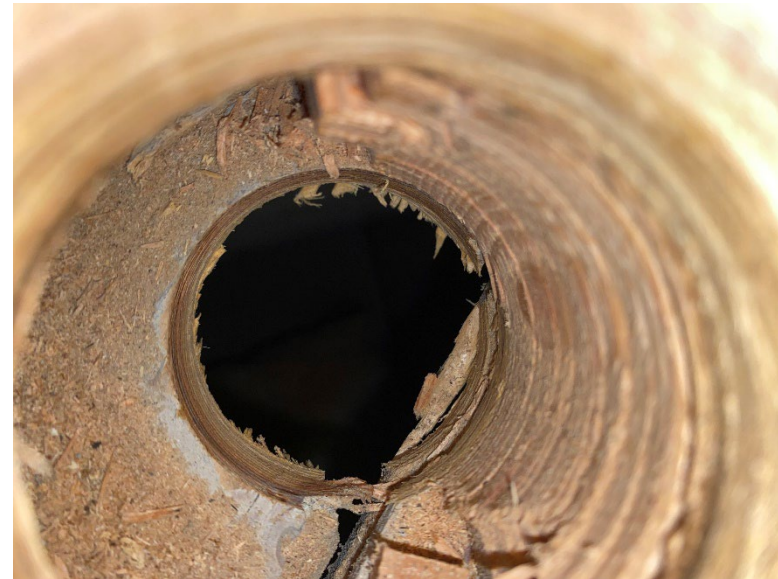
Original wood flooring was observed beneath the plywood subfloor.

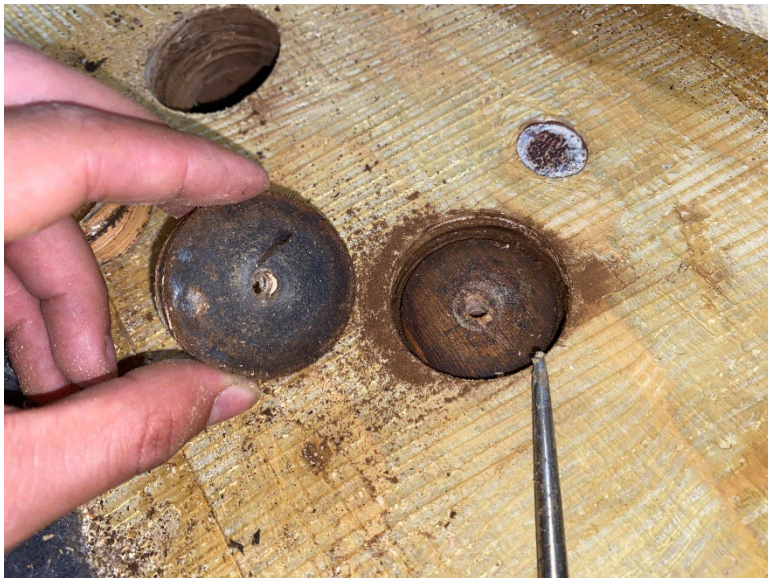
A black tar squeak paper was identified beneath the plywood subfloor.

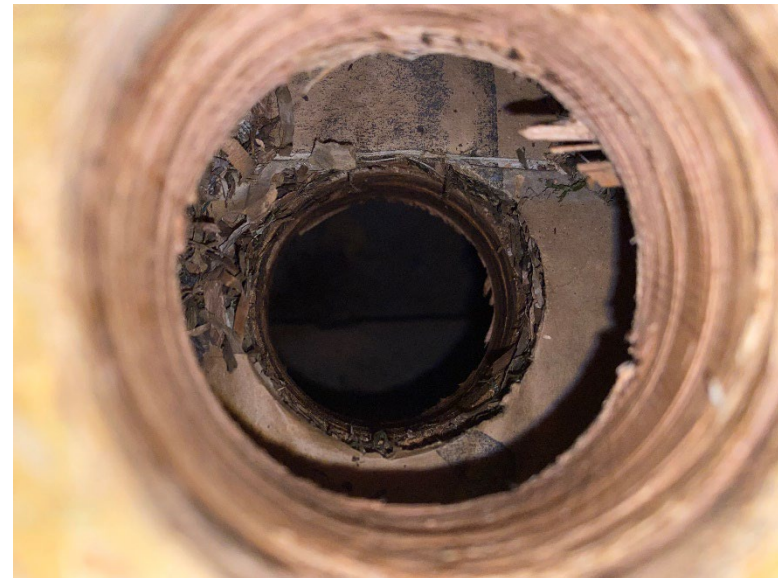
A brown squeak paper was identified in Room 206.
