## ARBORIST REPORT and SYNOPSIS

Area of focus: Trees near the grand stair case, see attached map

Purpose of reports: identify tree species and site condition as well as note trees with defects that could lead to premature failure. Also Identify trees that are invasive or otherwise inappropriate for this site.

*EASTERN OREGON UNIVERSITY*  
***GRAND STAIRCASE TOPOGRAPHIC SURVEY***

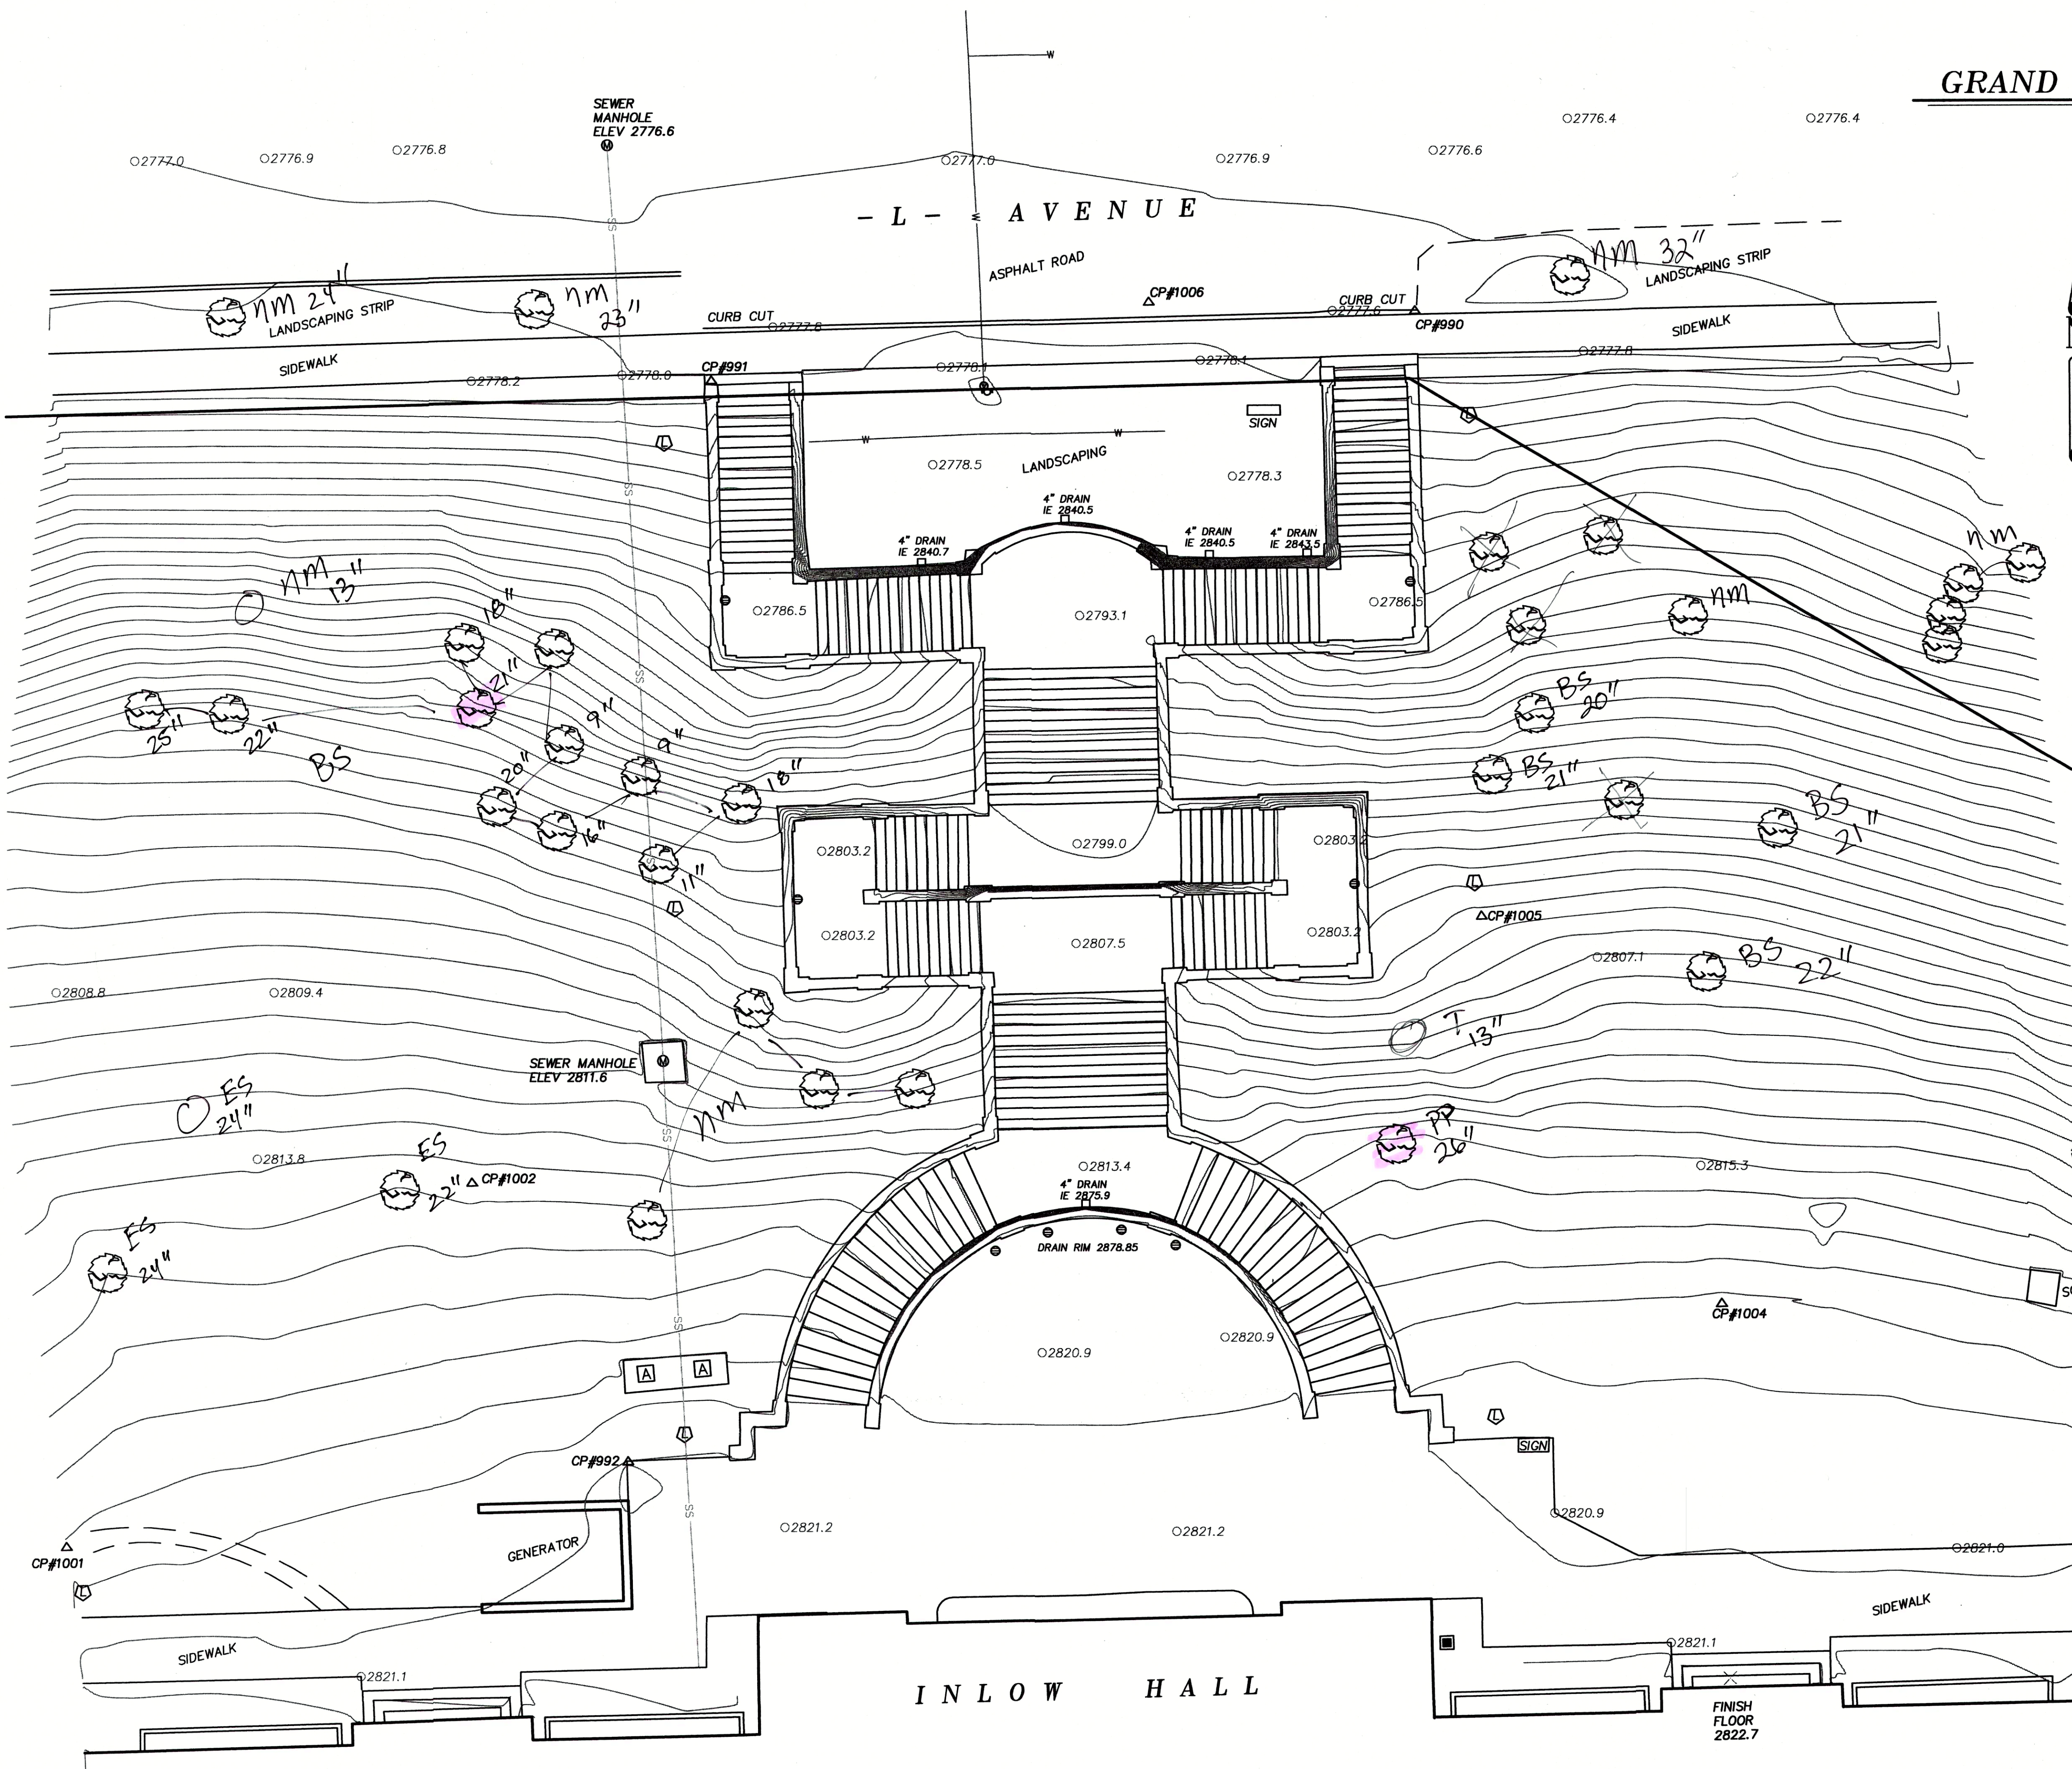
Site condition: steep (>30%), non-irrigated, north facing slope, minimal soil profile with round rock base, some sluffing and erosion evident.

- Defective trees: Ponderosa Pine (PP) immediately east of existing stair case has inferior form with multiple tops. Additionally, several of the spruce trees have compromised form as well. These trees are identified on the map provided.

- Norway Maples (NM) are a curious issue, listed by some as an invasive species they do serve a purpose in that they hold soils on steep ground well.
- There is significant risk involved with thinning the grove due the symbiotic nature of sheltering these trees have developed within. Even so we continue to somewhat regularly lose trees here because of severe wind shear and poor soil / root structure development.

- As to excavation around existing trees. Our campus tree plan identifies procedures for protection. To summarize these, we require fencing around protected trees and no excavating within drip line. These are the base requirements with some exceptions depending on species and site condition.
