Addendum 2

SOU Housing

Henry Street Houses

Photos & Explanations of Maintenance Needs

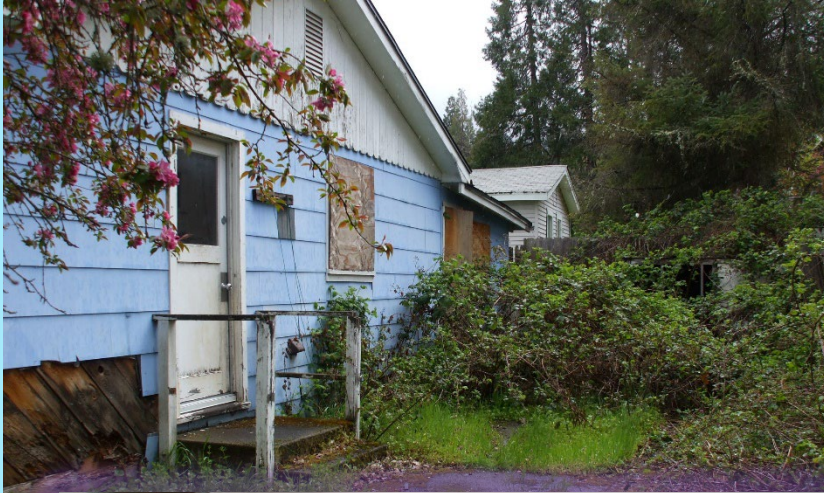
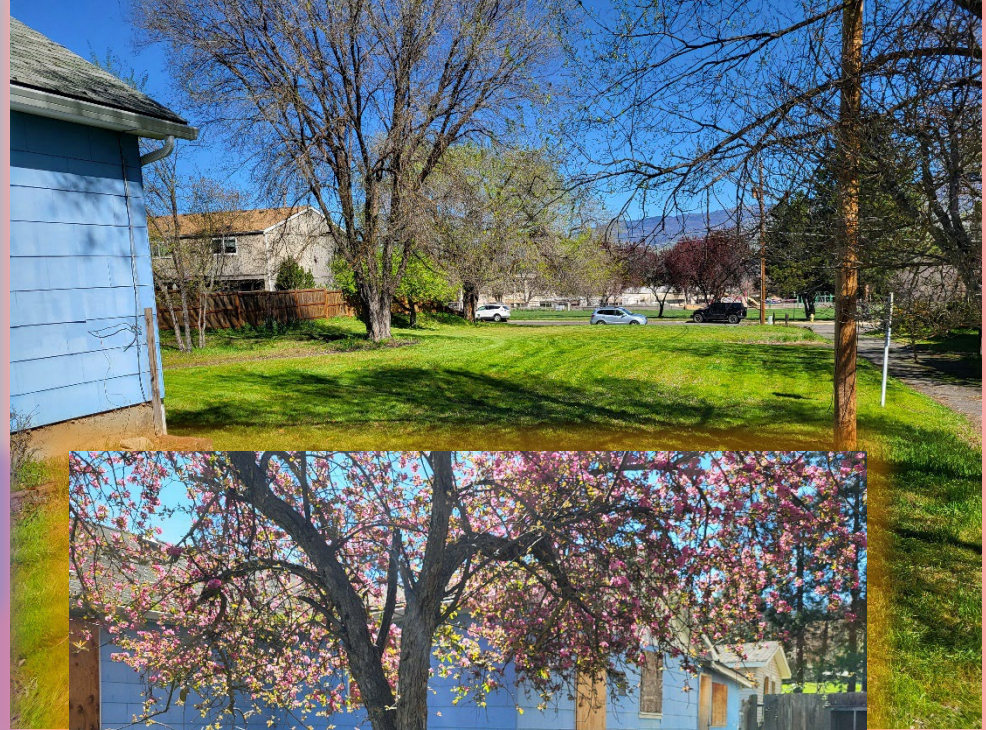
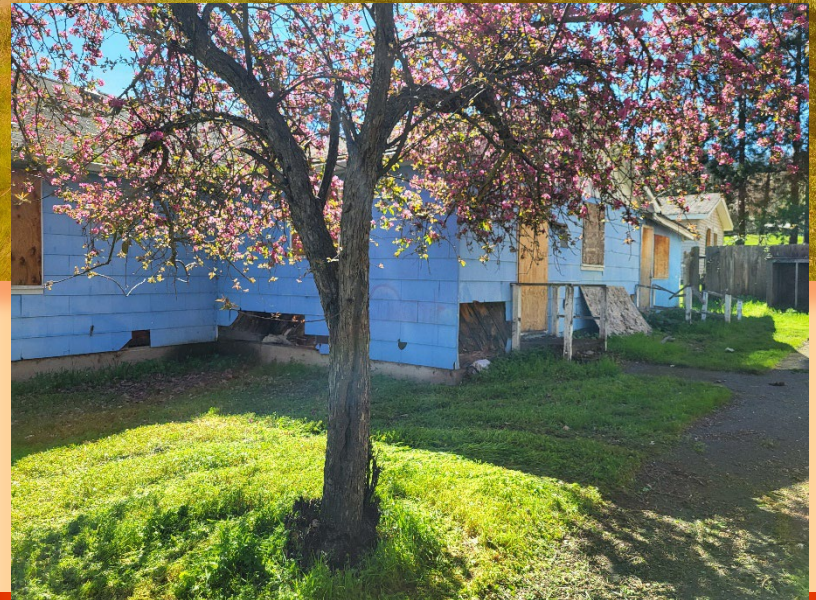
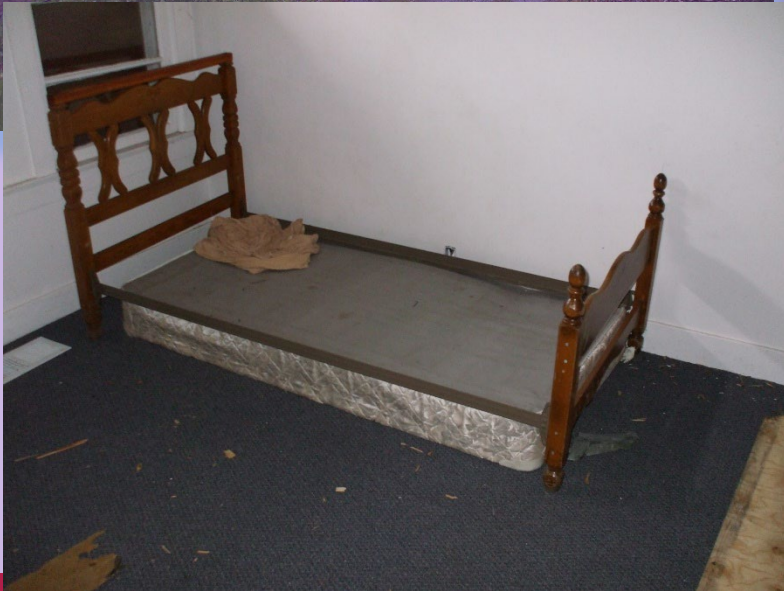
1038 Henry St

- Built in ?
 - Acquired in 1984
 - 1520 Sq. Ft.
 - 2 bedroom
 - 2 bath
- Major vandalism damage (windows, doors, interior)
 - Asbestos insulation & flooring
 - House unsafe due to structural damage from termites
 - Suspected lead based paint
 - Asbestos siding falling off from deterioration
 - Fence deteriorating (on property line shared with private apartments to the west)

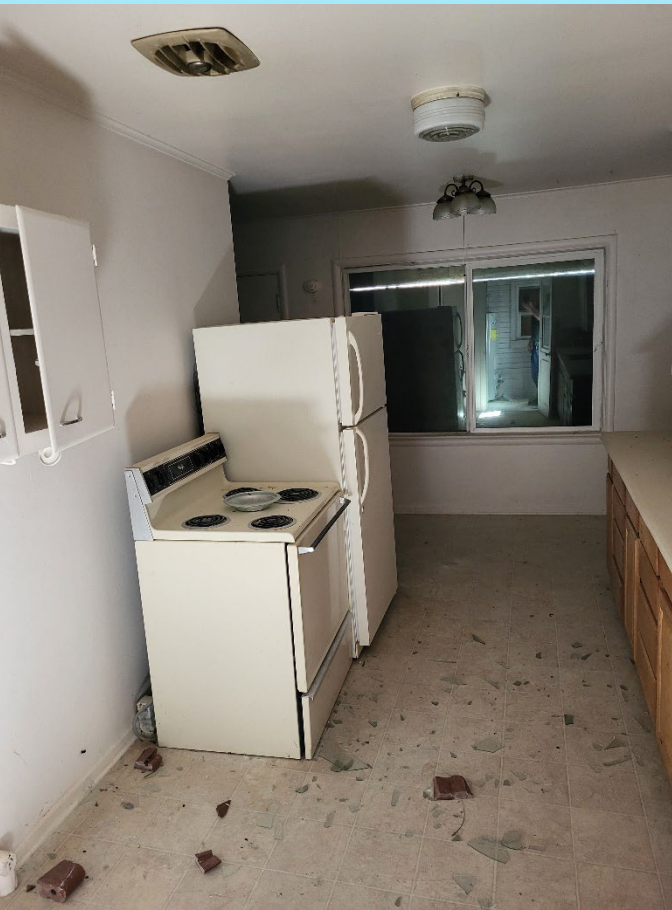
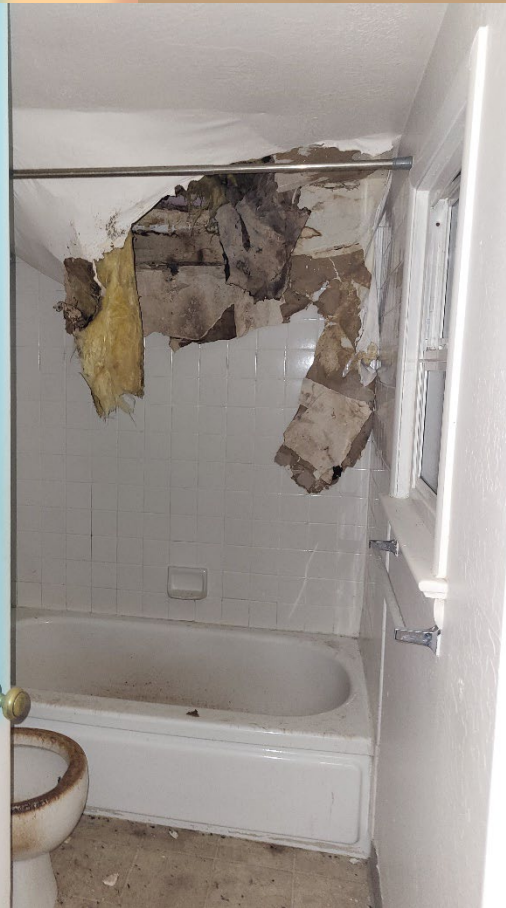
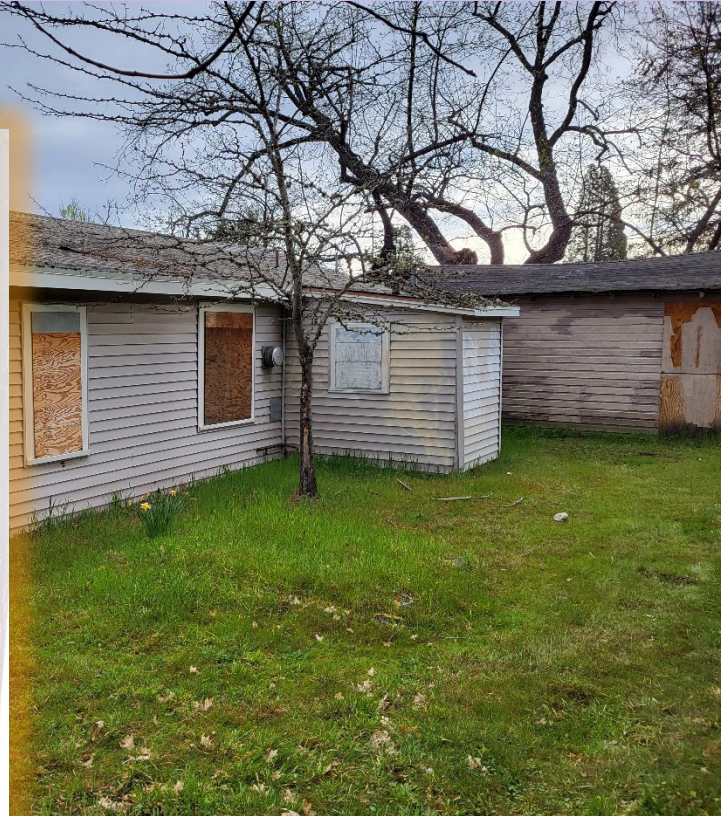
1040 Henry St

- Vinyl siding starting to deteriorate
- Suspected asbestos siding beneath vinyl siding
- Roof at end of life cycle, has leaked
- Bathroom ceiling collapsed on last inspection
- Garage is failing structurally
- Newer vinyl windows
- Partial kitchen remodel
- House not insulated
- No central HVAC, wall mounted gas furnace

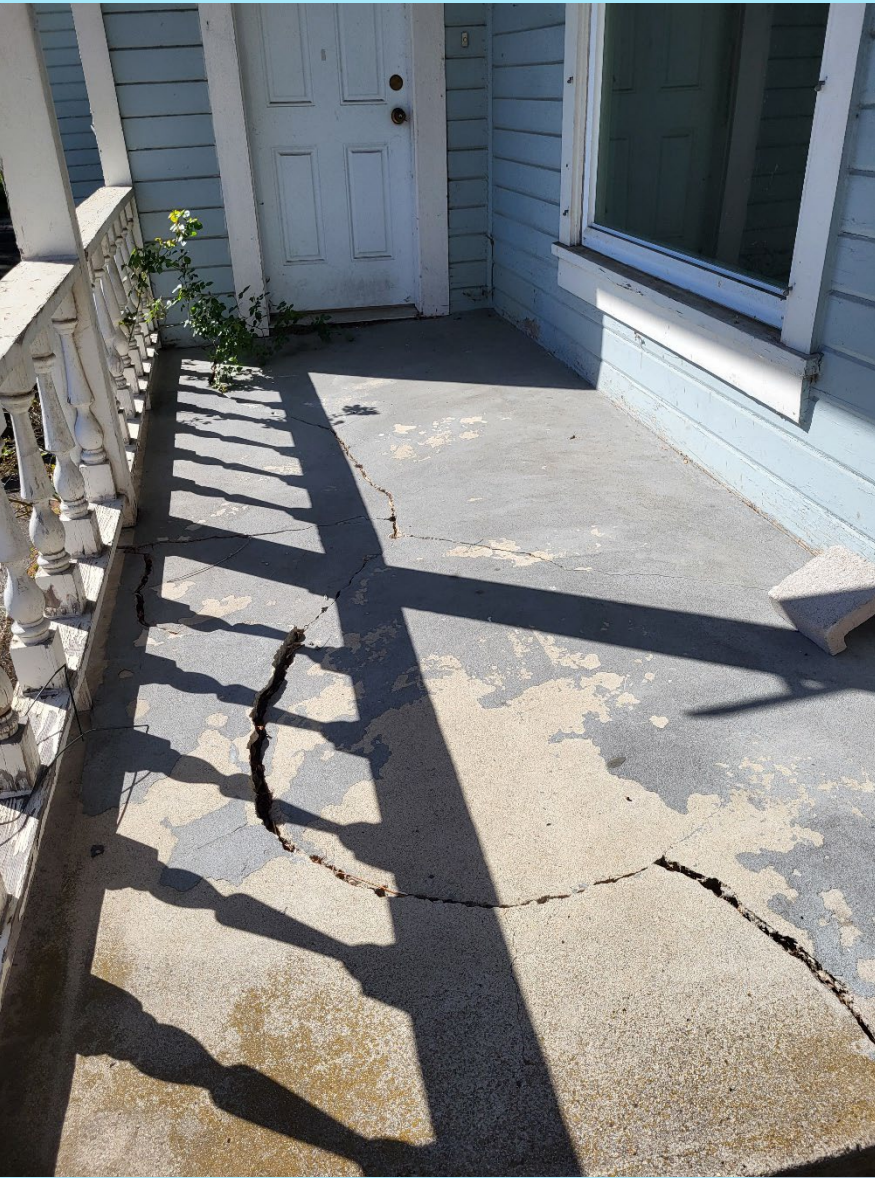
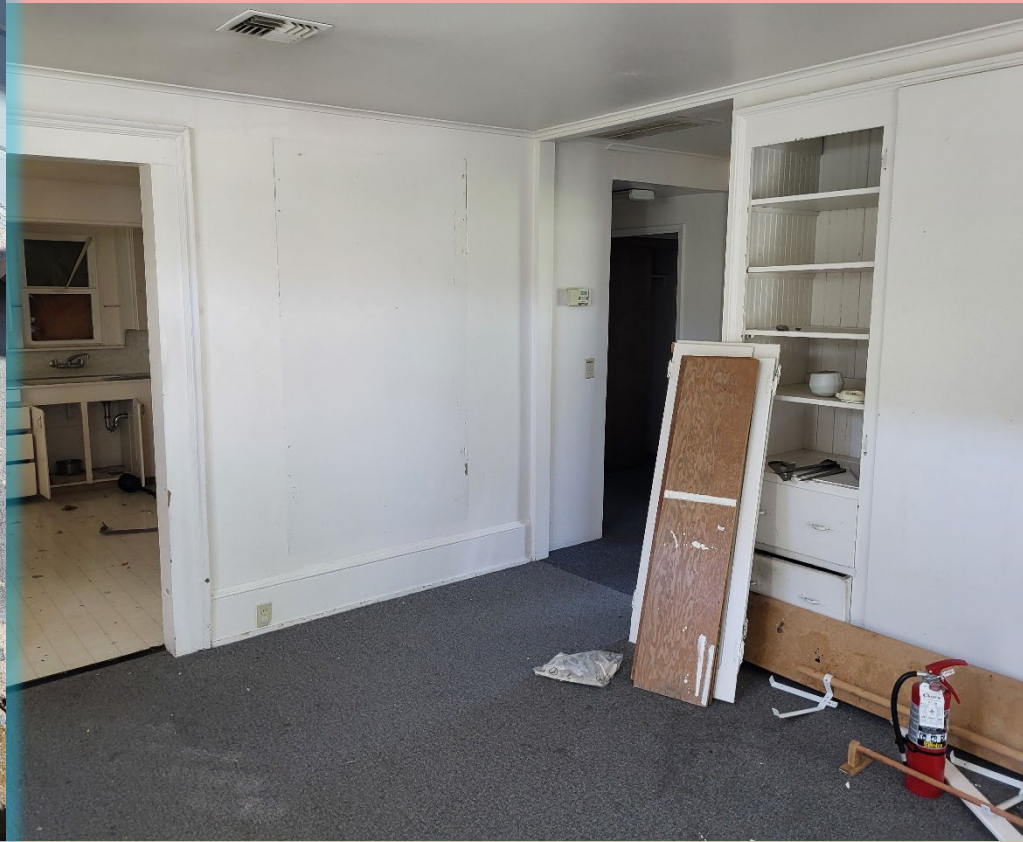
1056 Henry St

- Vandalism damage (windows)
- Asbestos siding
- Lead based paint flaking
- Foundation sinking (8" drop from corner to corner)
- Front porch separating & collapsing.
- Newer vinyl windows
- Was used as academic space in mid 2000's, IT infrastructure

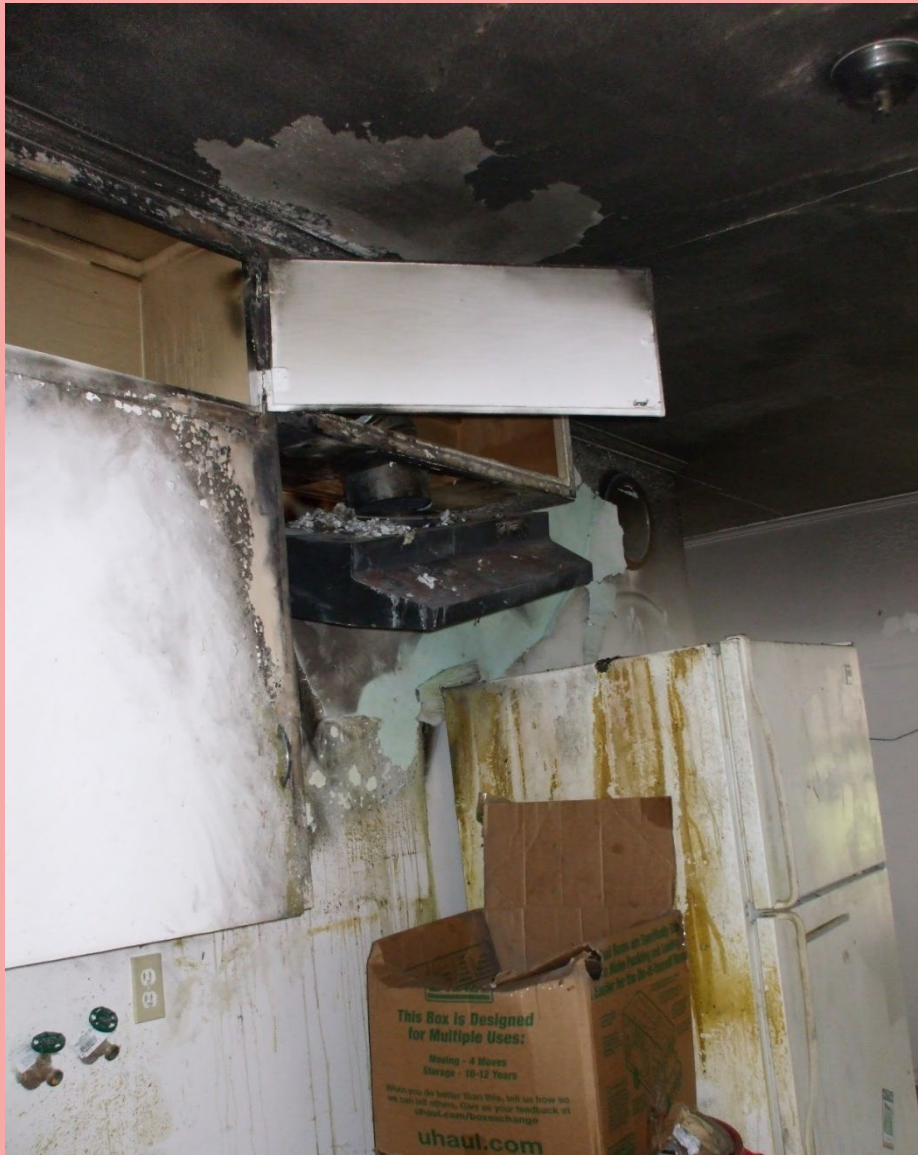
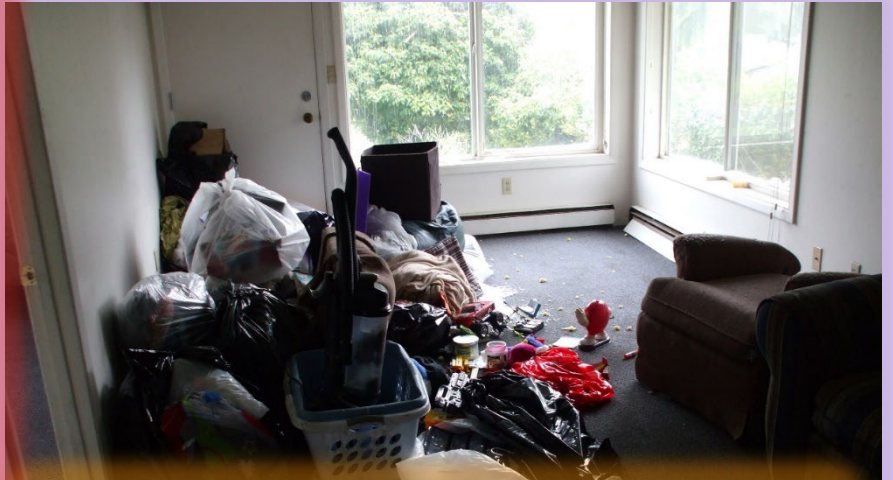
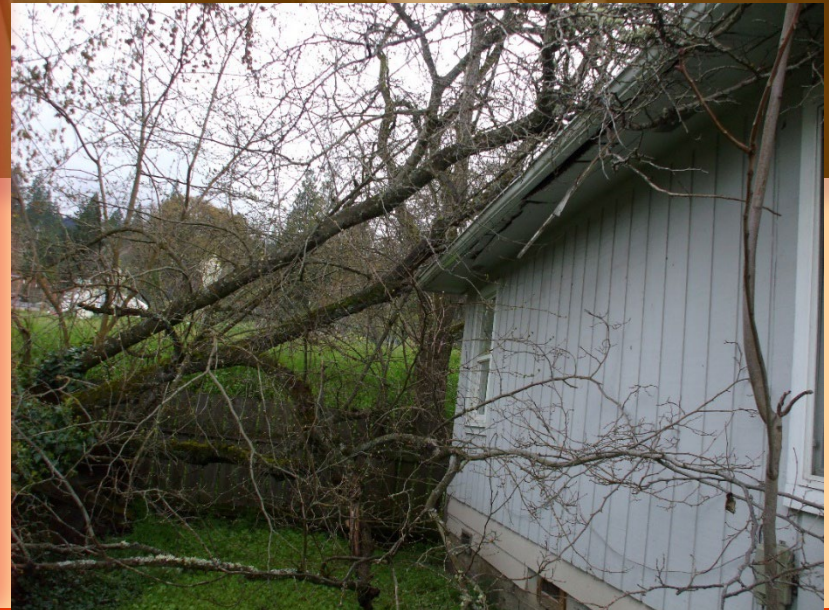
1058 Henry St

- Roof at end of life cycle.
- Carport not in good structural shape
- Fire damage in kitchen
- Smoke damage throughout house
- Rodent infestation
- No central HVAC, only a wall mounted gas furnace and a few baseboard heaters
- Foundation cracked in area of floor displacement
- Same tax lot as 1040 Henry St

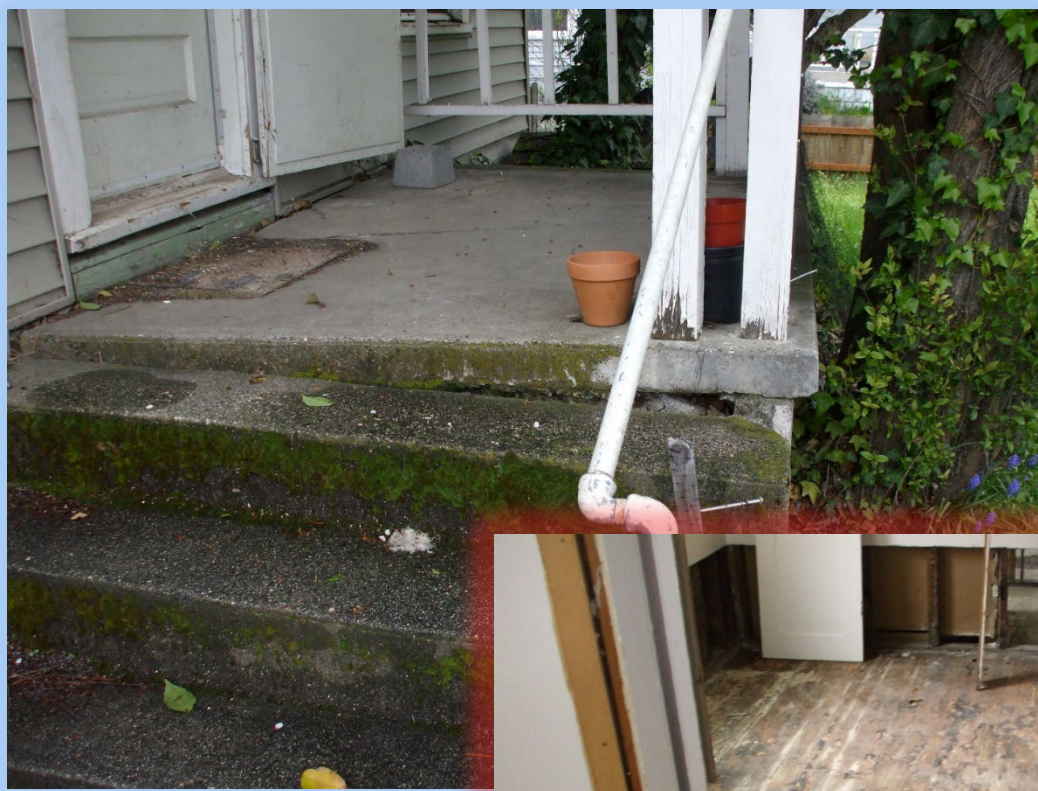
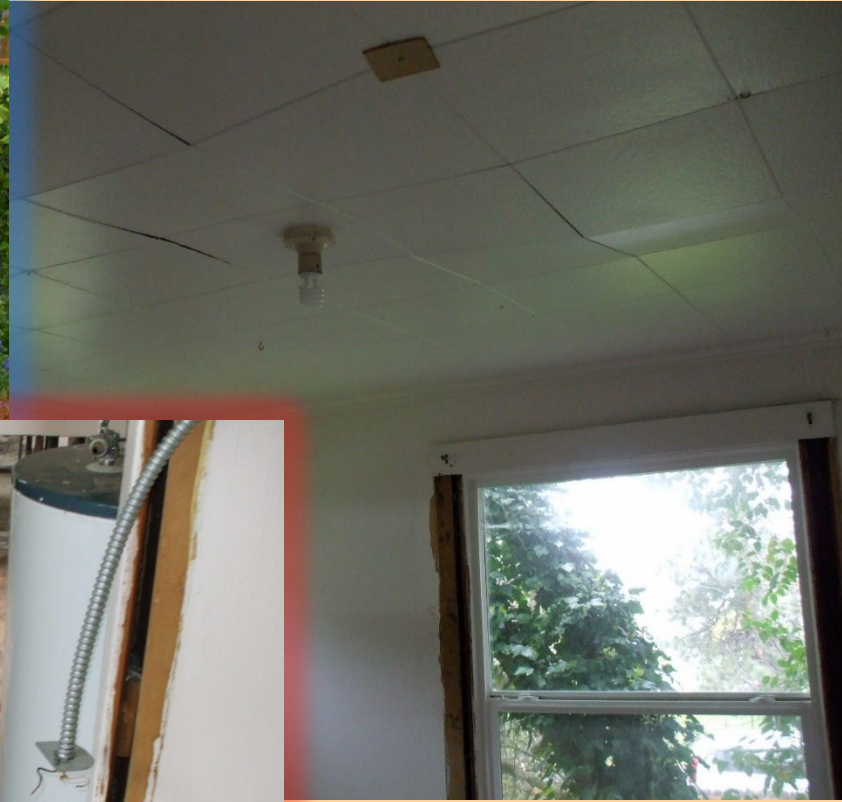
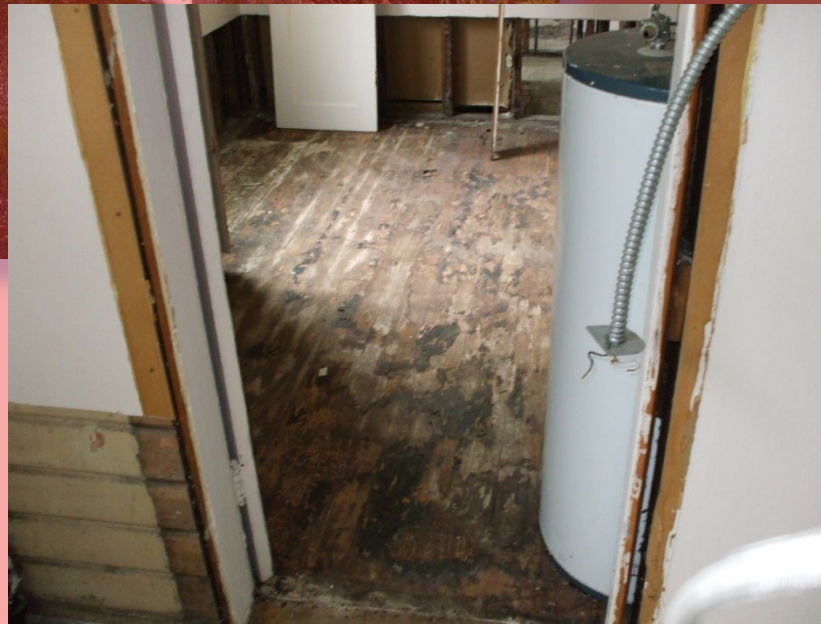
1066 Henry St

- Roof at end of life cycle
- No gutters
- Probable asbestos siding beneath deteriorating vinyl siding
- Front porch has lifted and separated from house due to trees
- Living room ceiling collapsed
- Interior of house “gutted” due to flood from pipe failure winter 2017
- Ceiling on NW corner is buckling due to foundation lifting
- Collapsed sewer line

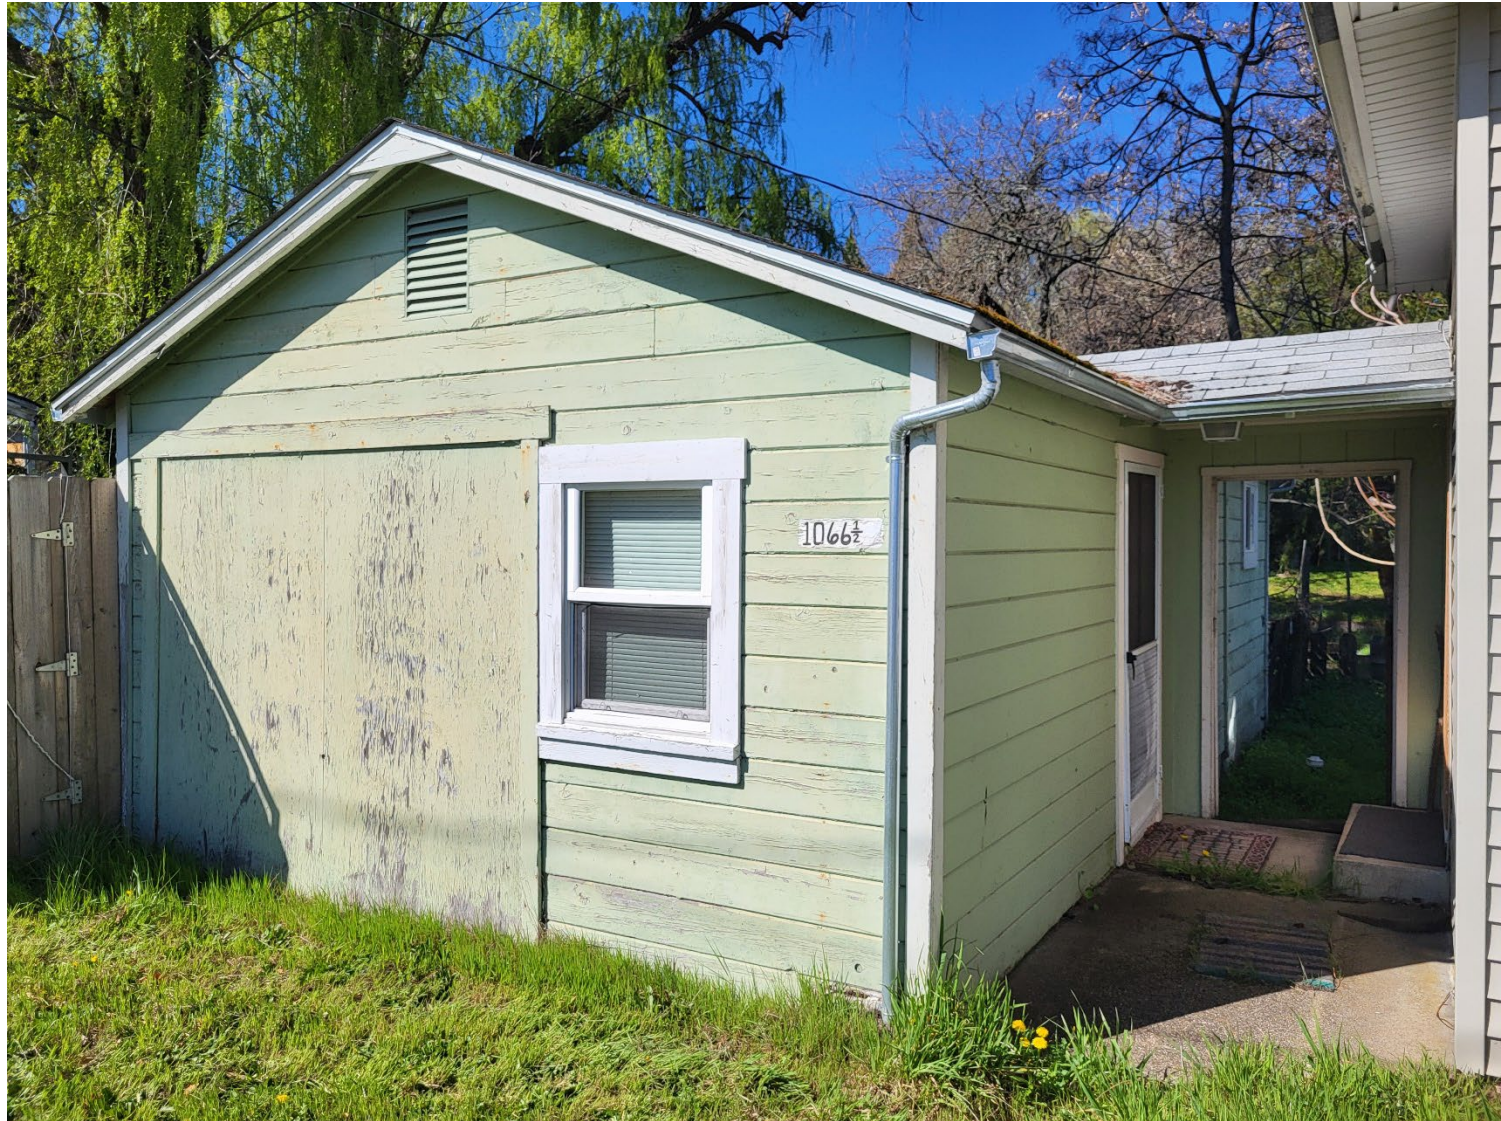
1066 ½ Henry St

- Physically attached to 1066 Henry St.
- Converted Garage
- Lead paint flaking
- Roof at end of life cycle
- Siding showing heavy wear
- Collapsed sewer line
- Fence in need of repair
