June 20, 2022

**Re: Limited Asbestos Containing Materials Inspection
Quinn Coliseum Tunnels, Eastern Oregon University Campus**

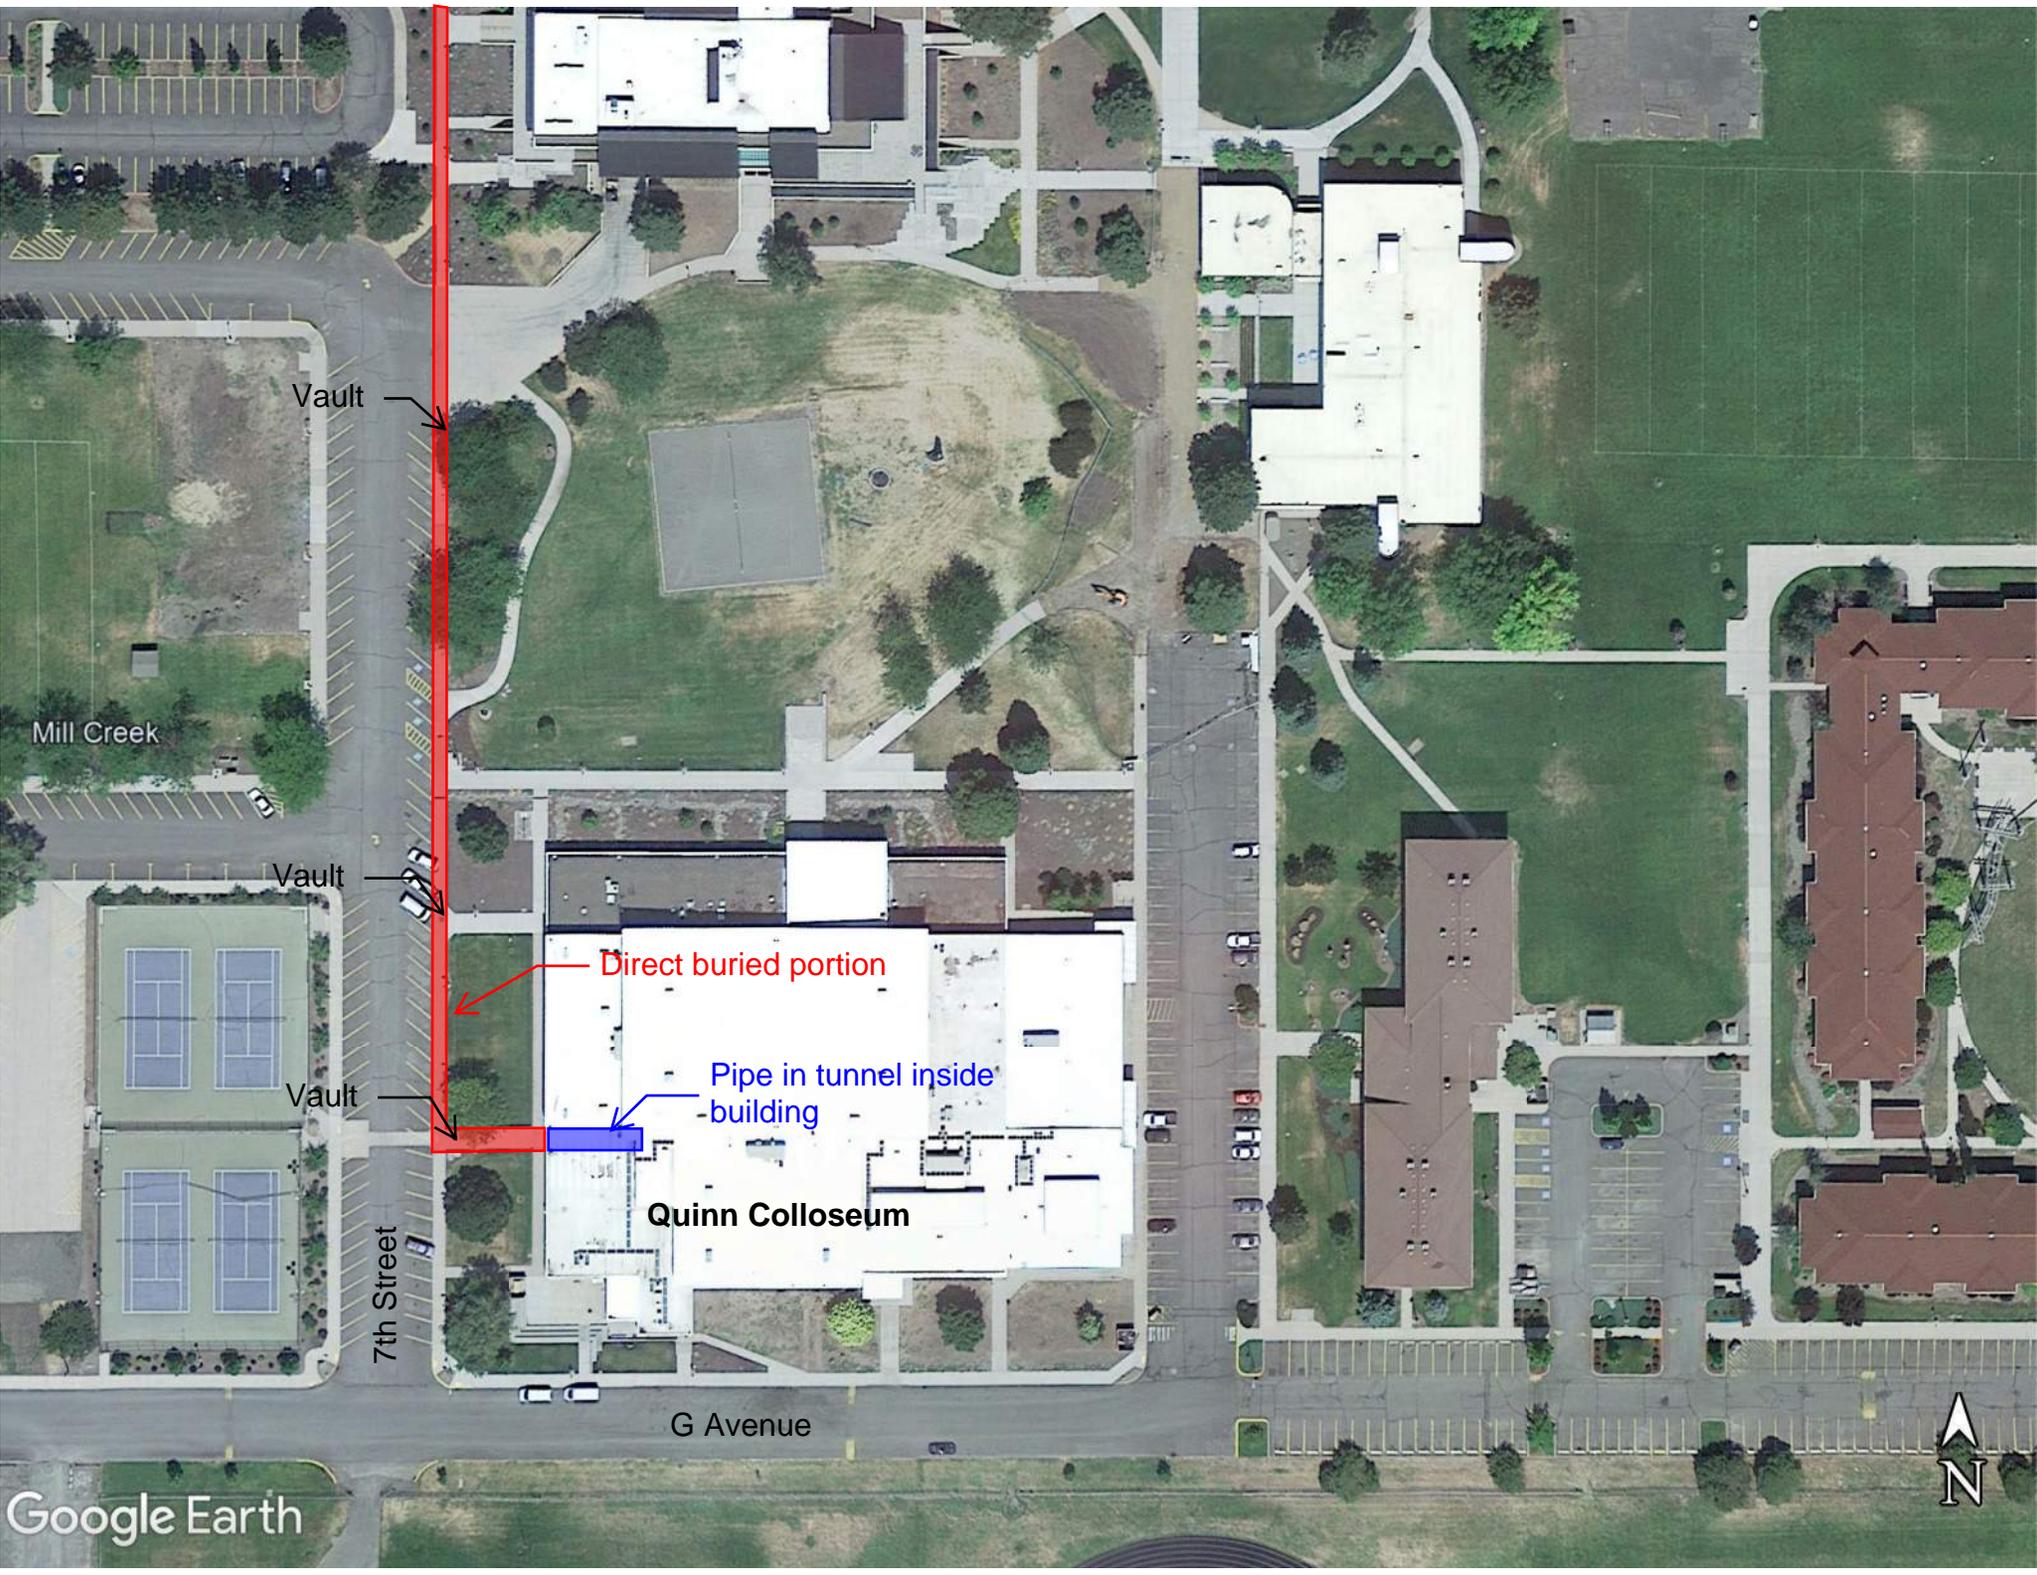
On June 3, 2022, Fulcrum Environmental Consulting, Inc. (Fulcrum), completed a limited asbestos containing materials (ACM) inspection of steam piping located on the Eastern Oregon University campus in La Grande, Oregon. Fulcrum understands that Eastern Oregon University is planning to replace a damaged steam line that services the Quinn Coliseum. Fulcrum's inspection is limited to the steam line and associated piping in select locations at the Quinn Coliseum. See Figure 1 for steam pipe map provided by Eastern Oregon University.

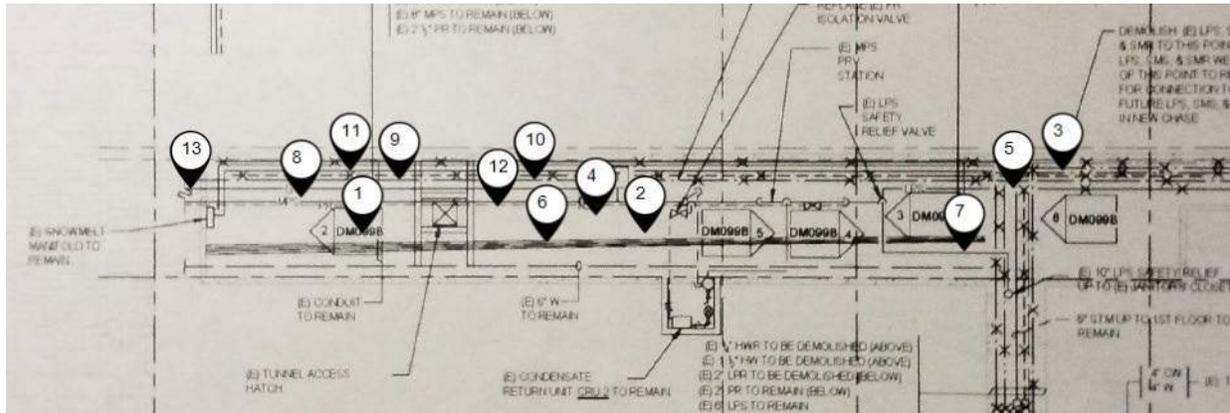
Figure 2: ACM Sample Locations – Tunnel

Map ID	Sample ID	Section Name	Location	Index	Material
1	6322-001	Tunnel	West	TSI-01	White wrap over fiberglass insulation around 2-inch pipe runs
2	6322-002	Tunnel	Center	TSI-01	White wrap over fiberglass insulation around 2-inch pipe runs
3	6322-003	Tunnel	East	TSI-01	White wrap over fiberglass insulation around 2-inch pipe runs
1	6322-004	Tunnel	West	TSI-02	White plastic over fiberglass insulation around 2-inch JETs
2	6322-005	Tunnel	Center	TSI-02	White plastic over fiberglass insulation around 2-inch JETs
3	6322-006	Tunnel	East	TSI-02	White plastic over fiberglass insulation around 2-inch JETs
1	6322-007	Tunnel	West	TSI-03	White wrap over fiberglass insulation around 4-inch pipe runs
4	6322-008	Tunnel	Center	TSI-03	White wrap over fiberglass insulation around 4-inch pipe runs
5	6322-009	Tunnel	East	TSI-03	White wrap over fiberglass insulation around 4-inch pipe runs
1	6322-010	Tunnel	West	TSI-04	White plastic over fiberglass insulation around 4-inch JETs

4	6322-011	Tunnel	Center	TSI-04	White plastic over fiberglass insulation around 4-inch JETs
5	6322-012	Tunnel	East	TSI-04	White plastic over fiberglass insulation around 4-inch JETs
1	6322-013	Tunnel	West	TSI-05	White wrap over fiberglass insulation around 6-inch pipe runs
6	6322-014	Tunnel	Center	TSI-05	White wrap over fiberglass insulation around 6-inch pipe runs
7	6322-015	Tunnel	East	TSI-05	White wrap over fiberglass insulation around 6-inch pipe runs
1	6322-016	Tunnel	West	TSI-06	White plastic over fiberglass insulation around 6-inch JETs

Map ID	Sample ID	Section Name	Location	Index	Material
6	6322-017	Tunnel	Center	TSI-06	White plastic over fiberglass insulation around 6-inch JETs
7	6322-018	Tunnel	East	TSI-06	White plastic over fiberglass insulation around 6-inch JETs
8	6322-019	Tunnel	West	TSI-07	White wrap over fiberglass insulation around 8-inch pipe runs
10	6322-020	Tunnel	Center	TSI-07	White wrap over fiberglass insulation around 8-inch pipe runs
9	6322-021	Tunnel	West	TSI-07	White wrap over fiberglass insulation around 8-inch pipe runs
11	6322-022	Tunnel	West	TSI-08	White plastic over fiberglass insulation around 8-inch JETs
10	6322-023	Tunnel	Center	TSI-08	White plastic over fiberglass insulation around 8-inch JETs
11	6322-024	Tunnel	West	TSI-08	White plastic over fiberglass insulation around 8-inch JETs
9	6322-025	Tunnel	West	TSI-09	White wrap over fiberglass insulation around 10-inch pipes
12	6322-026	Tunnel	Center	TSI-09	White wrap over fiberglass insulation around 10-inch pipes

12	6322-027	Tunnel	Center	TSI-09	White wrap over fiberglass insulation around 10-inch pipes
9	6322-028	Tunnel	West	TSI-10	White plastic over fiberglass insulation around 10-inch JETs
12	6322-029	Tunnel	Center	TSI-10	White plastic over fiberglass insulation around 10-inch JETs
12	6322-030	Tunnel	Center	TSI-10	White plastic over fiberglass insulation around 10-inch JETs
13	6322-031	Tunnel	West	TSI-11	Black wrap over gray fibrous insulation around 8-inch pipe that extends underground
13	6322-032	Tunnel	West	TSI-11	Black wrap over gray fibrous insulation around 8-inch pipe that extends underground
13	6322-033	Tunnel	West	TSI-11	Black wrap over gray fibrous insulation around 8-inch pipe that extends underground
13	6322-034	Tunnel	West	MSC-01	Black tar material on concrete exterior of underground pipe entrance
13	6322-035	Tunnel	West	MSC-01	Black tar material on concrete exterior of underground pipe entrance

13	6322-036	Tunnel	West	MSC-01	Black tar material on concrete exterior of underground pipe entrance

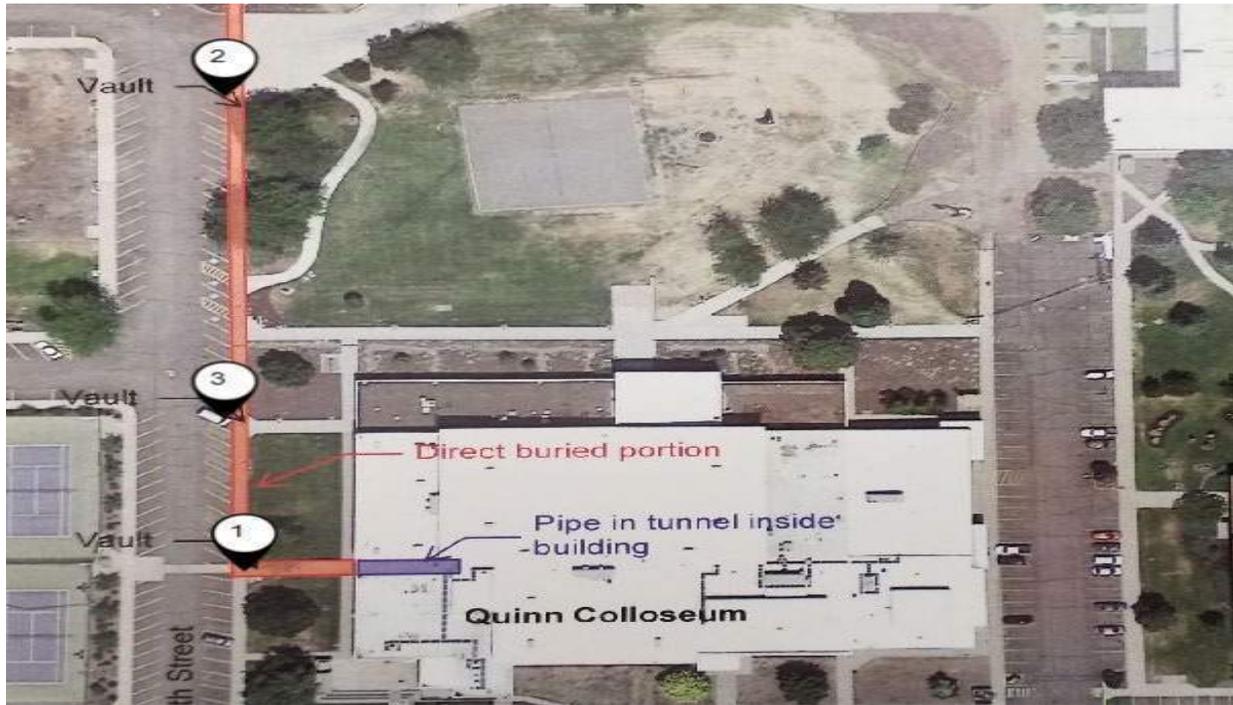
Figure 3: ACM Sample Locations – Vaults

Map ID	Sample ID	Section Name	Location	Index	Material
1	6322-037	Vault 1	Center	TSI-12	Metal cover over fiberglass insulation on 8-inch pipe run
1	6322-038	Vault 1	Center	TSI-12	Metal cover over fiberglass insulation on 8-inch pipe run
1	6322-039	Vault 1	Center	TSI-12	Metal cover over fiberglass insulation on 8-inch pipe run
1	6322-040	Vault 1	Center	TSI-13	White cloth wrap over fiberglass insulation around valves
1	6322-041	Vault 1	Center	TSI-13	White cloth wrap over fiberglass insulation around valves
1	6322-042	Vault 1	Center	TSI-15	White cloth wrap over fiberglass insulation around valves
3	6322-043	Vault 2	South	TSI-15	Brown wrap over gray fibrous insulation around 8-inch pipe run
3	6322-044	Vault 2	South	TSI-15	Brown wrap over gray fibrous insulation around 8-inch pipe run
3	6322-045	Vault 2	North	TSI-15	Brown wrap over gray fibrous insulation around 8-inch pipe run
3	6322-046	Vault 2	Center	TSI-15	Residual pipe insulation on rusty deteriorated pipe

3	6322-047	Vault 2	Center	TSI-15	Residual pipe insulation on rusty deteriorated pipe
3	6322-048	Vault 2	Center	TSI-15	Residual pipe insulation on rusty deteriorated pipe

Map ID	Sample ID	Section Name	Location	Index	Material
2	6322-049	Vault 3	South	TSI-16	Metal cover over fiberglass insulation around 8-inch pipe run
2	6322-050	Vault 3	South	TSI-16	Metal cover over fiberglass insulation around 8-inch pipe run
2	6322-051	Vault 3	North	TSI-16	Metal cover over fiberglass insulation around 8-inch pipe run
2	6322-052	Vault 3	Center	TSI-17	White cloth wrap over fiberglass insulation around valves
2	6322-053	Vault 3	Center	TSI-17	White cloth wrap over fiberglass insulation around valves
2	6322-054	Vault 3	Center	TSI-17	White cloth wrap over fiberglass insulation around valves
2	6322-055	Vault 3	Center	TSI-18	Residual pipe insulation on rusty deteriorated pipe
2	6322-056	Vault 3	Center	TSI-18	Residual pipe insulation on rusty deteriorated pipe
2	6322-057	Vault 3	Center	TSI-18	Residual pipe insulation on rusty deteriorated pipe
2	6322-058	Vault 3	East	MSC-02	Red gasket between pipes

2	6322-059	Vault 3	East	MSC-02	Red gasket between pipes
2	6322-060	Vault 3	East	MSC-02	Red gasket between pipes

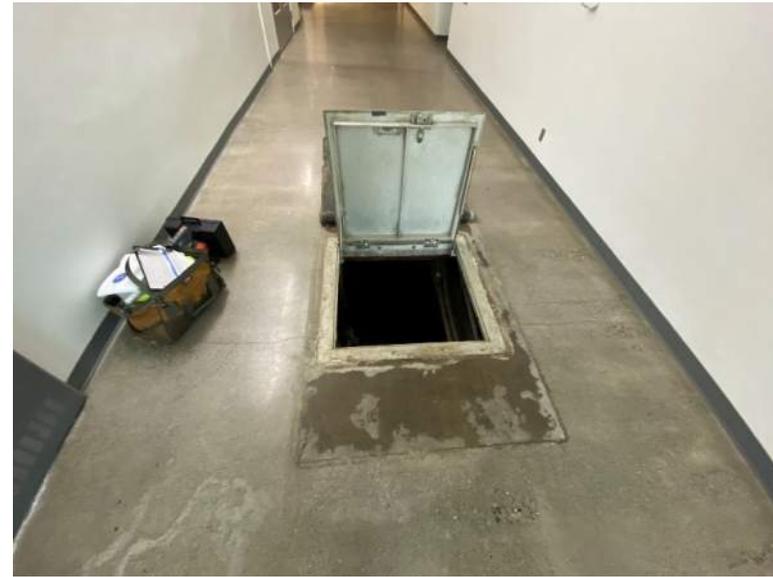
The tunnel is accessed through a hatch located in the southwest hallway near the southwest entrance.

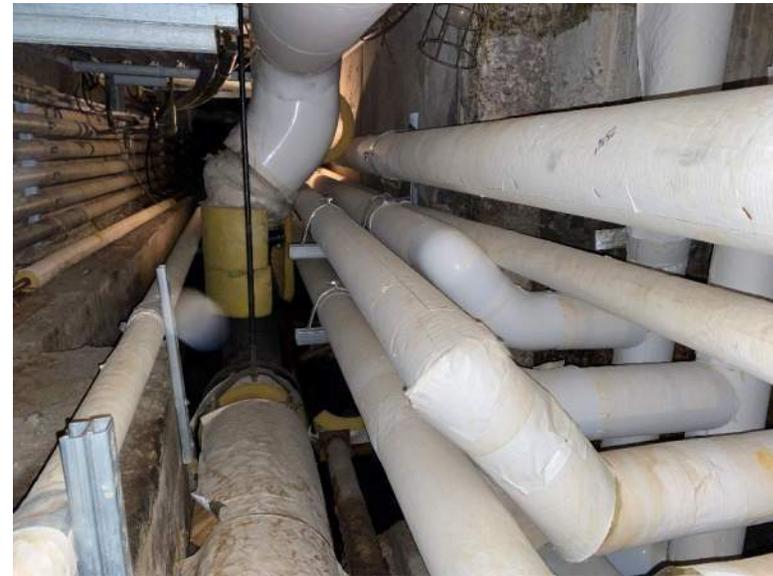
Most pipes were observed with newer fiberglass insulation.

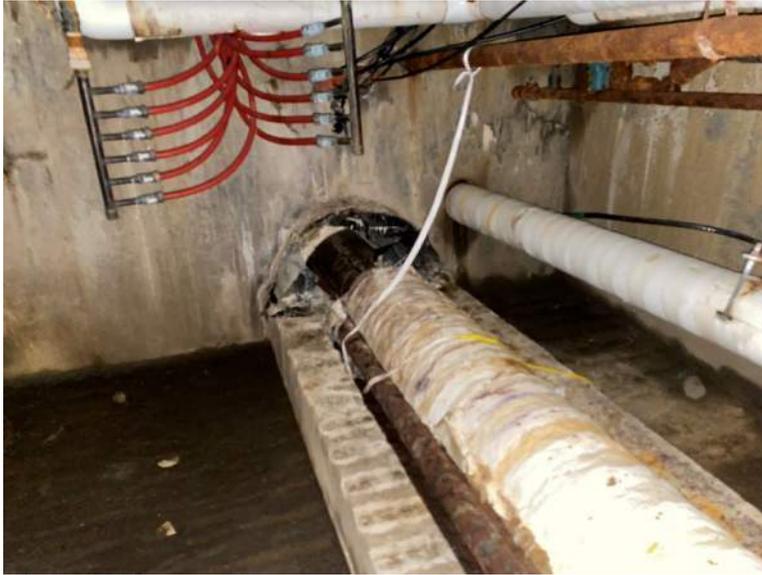
The main steam line was observed to be in poor condition.

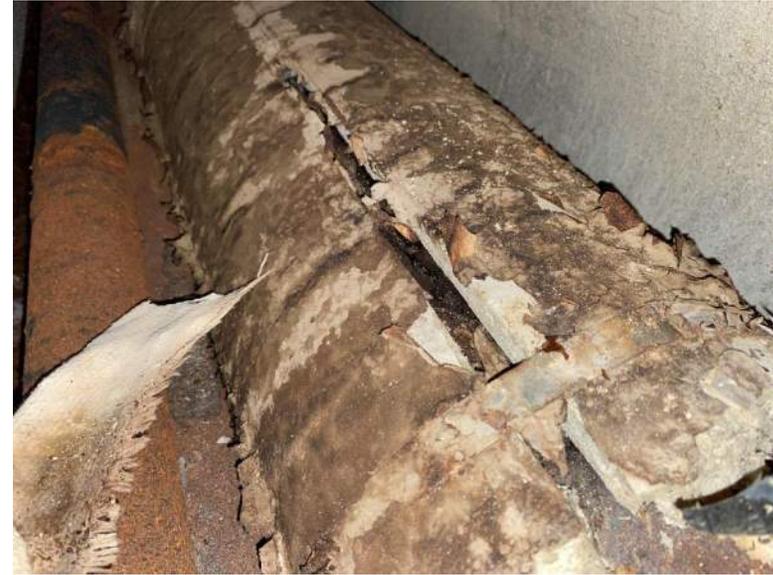
Laboratory analysis identified **60% Amosite** asbestos in the gray insulation sampled from the 8-inch main steam line in the tunnel and **65% Amosite** asbestos in the gray insulation sampled from Vault 2. The black tar sampled on concrete in the Quinn Coliseum tunnel was identified with **70% Chrysotile** asbestos.

The gray fibrous insulation was identified with 60% Amosite asbestos.

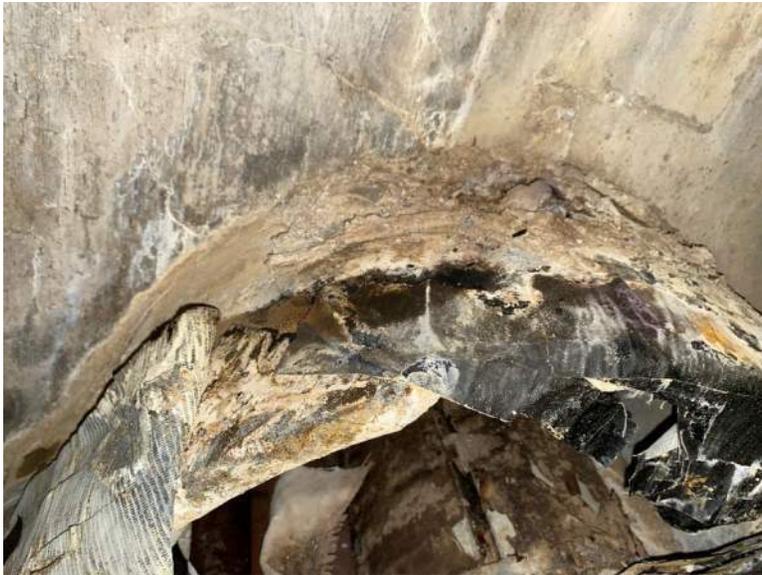
A black tar material was observed on concrete above the steam line. The black tar was identified with 12% Chrysotile asbestos.

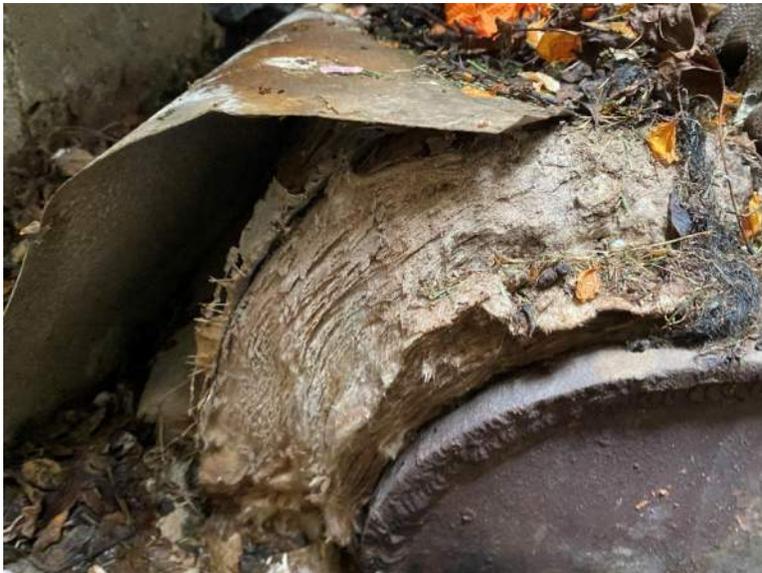
The steam line in Vault 1 was observed with a metal cover and fiberglass insulation.

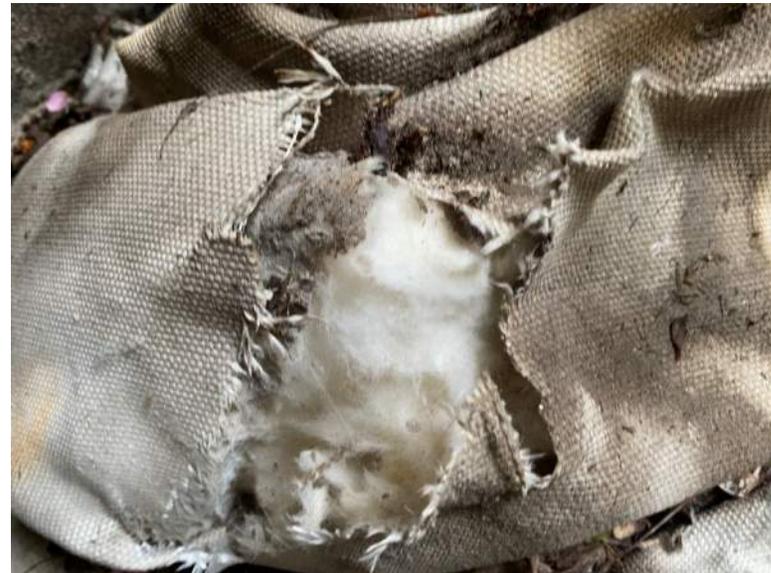
The valve was observed with a blanket covering composed of white wrap with fiberglass insulation.

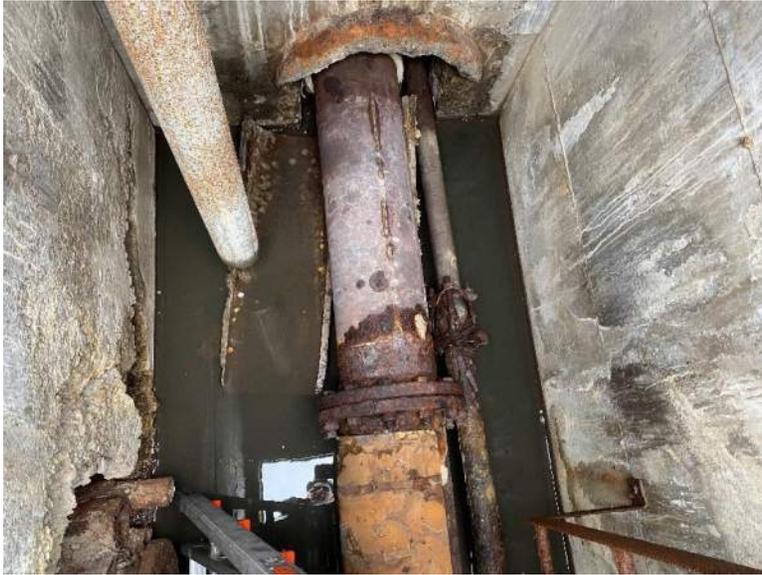
The steam line observed with damaged insulation in Vault 2.

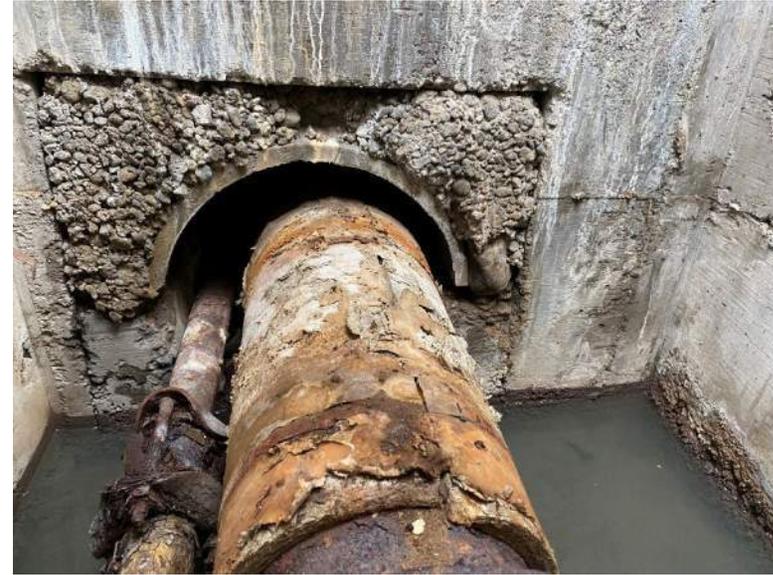
The insulation around the steam line was observed to be in poor condition.

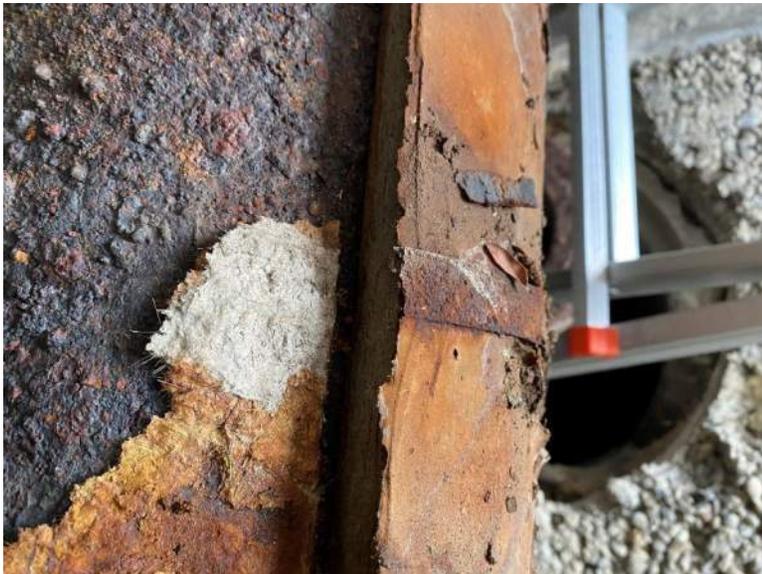
The insulation was identified with 60% Amosite asbestos.

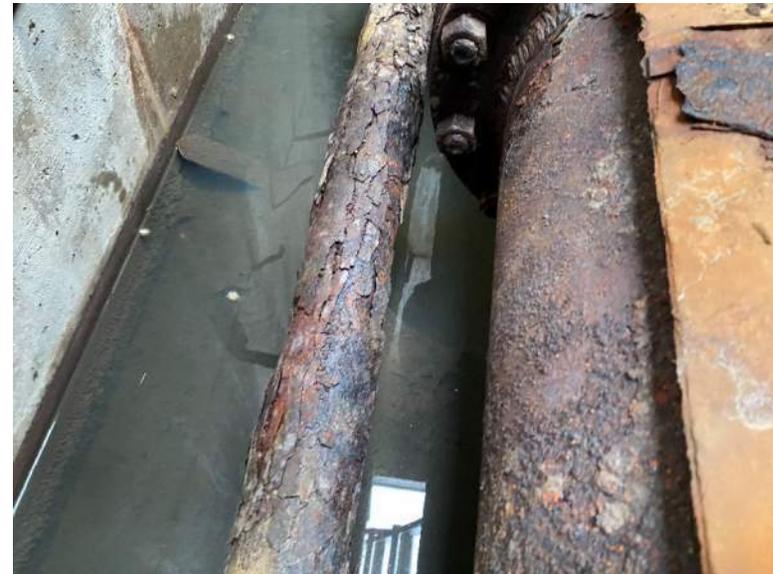
A 4-inch deteriorated pipe was observed next to the steam line in Vault 2.

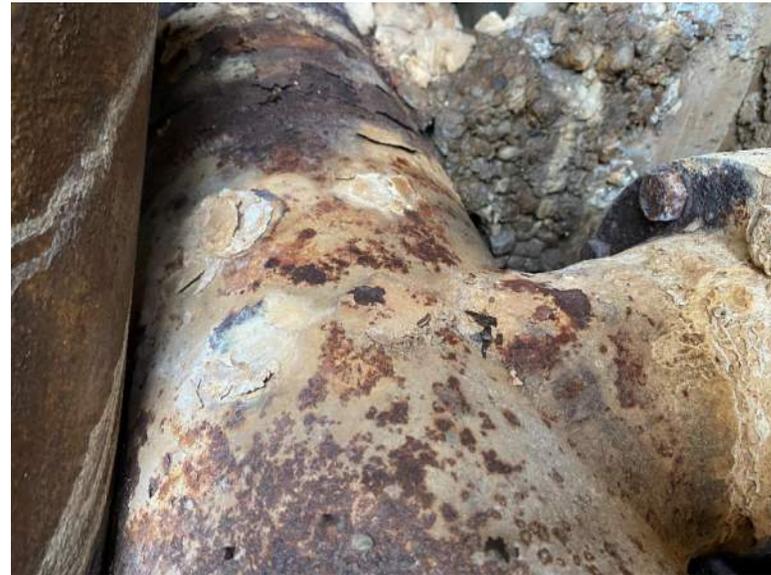
The section of the steam line in Vault 3 was observed with deteriorated insulation.

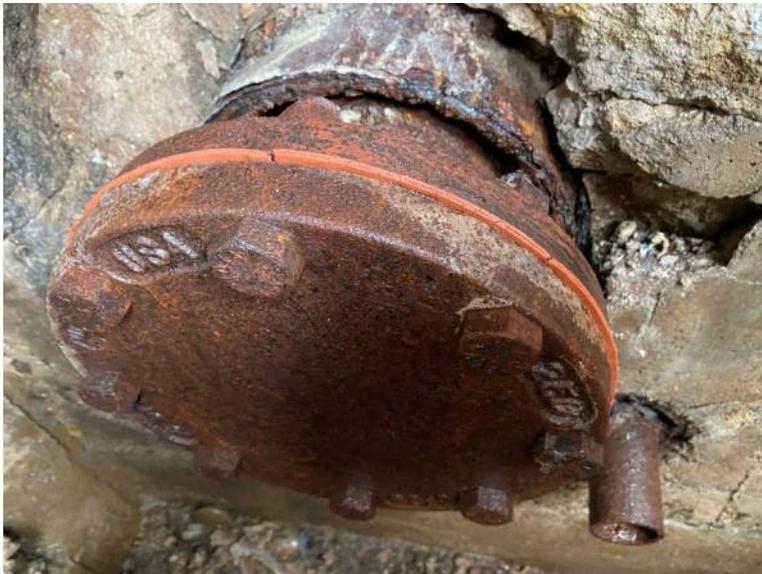
A flange gasket was observed in Vault 3.
