Hazardous Building Materials Inspection Report

Inlow Hall
One University Boulevard
La Grande, Oregon 997850

Project Number: 223507.00

June 16, 2022

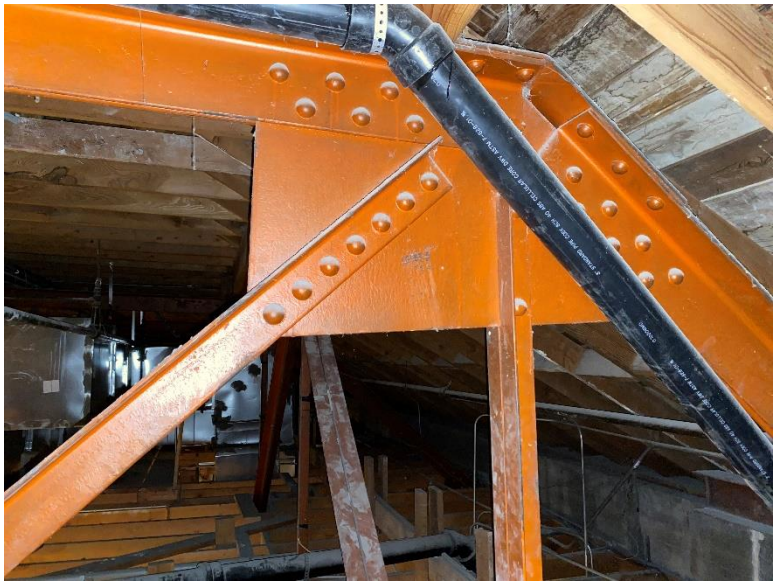
Orange paint on structural steel in the mezzanine contains lead.

Red paint on steel beams in the mezzanine contains lead.

White paint on plaster walls on the second floor contains lead.

Tan paint on plaster walls on the second floor contains lead.

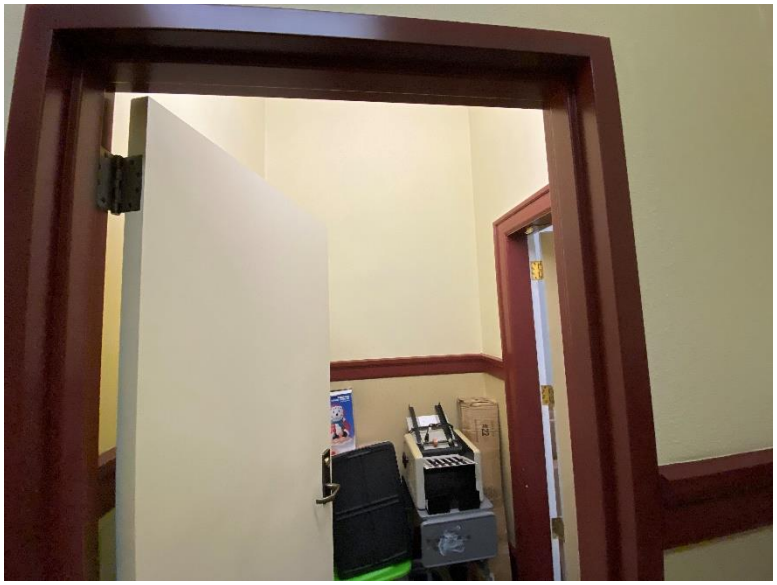
Red paint on metal door frame on the second floor contains lead.

White paint on wood window sill on the second floor contains lead.

Gray paint on wood door frame on the first floor contains lead.

Green paint on concrete wall in the basement contains lead.

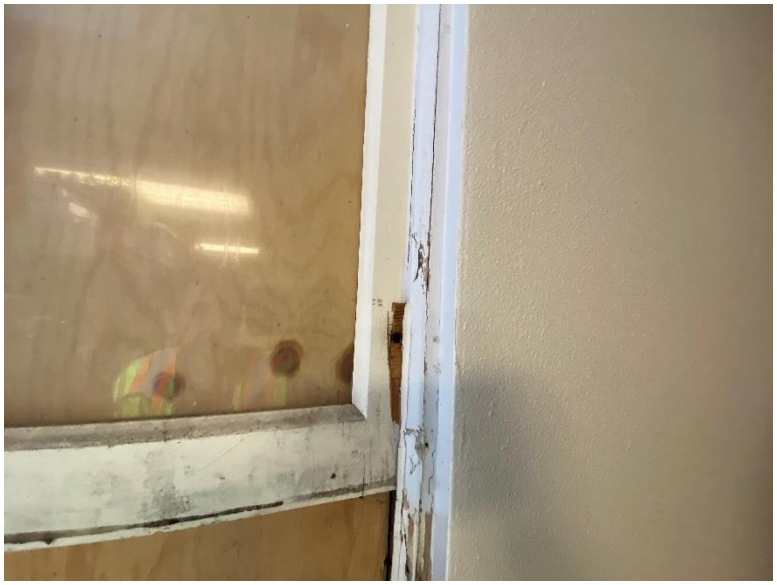
White paint on wood windowsill in the basement contains lead.

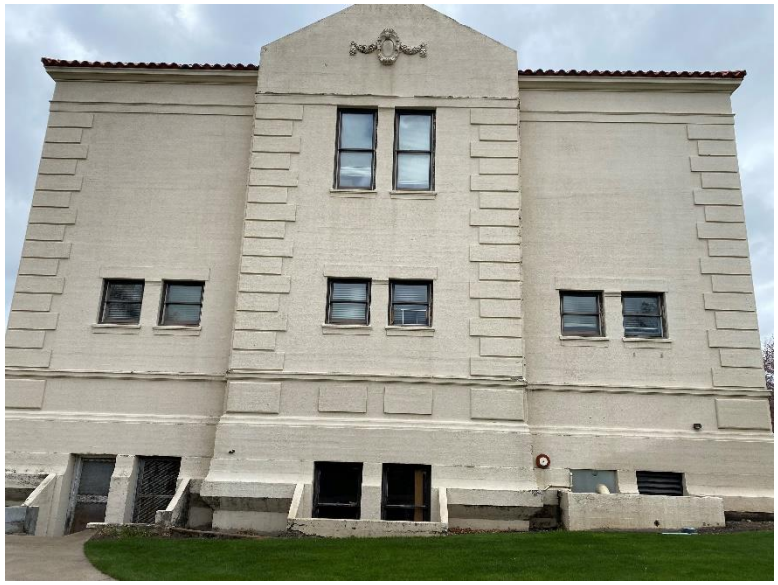
Black paint on wood exterior windows on the basement, first, and second floor contains lead.

White paint on wood exterior door to the basement contains lead.
