Addendum 2

SOU Housing

Henry Street Houses

Photos & Explanations of Maintenance Needs

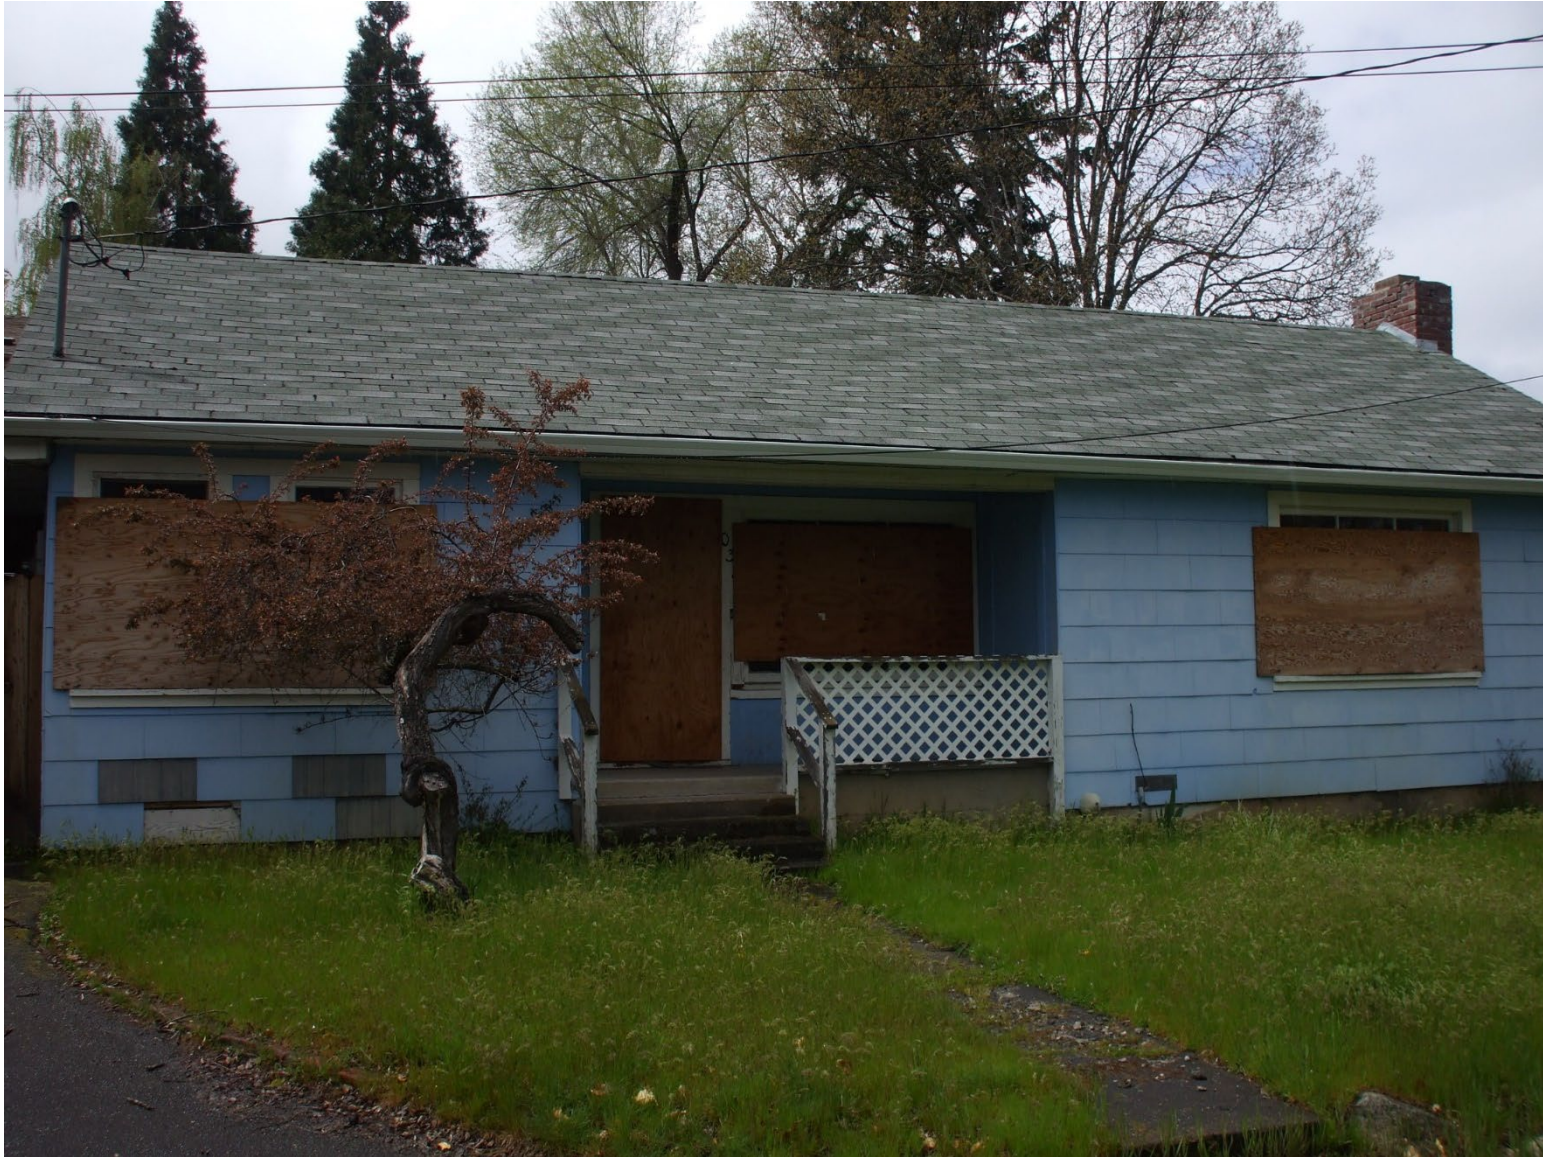
1038 Henry St

- Built in ?
 - Acquired in 1984
 - 1520 Sq. Ft.
 - 2 bedroom
 - 2 bath
- Major vandalism damage (windows, doors, interior)
 - Asbestos insulation & flooring
 - House unsafe due to structural damage from termites
 - Suspected lead based paint
 - Asbestos siding falling off from deterioration
 - Fence deteriorating (on property line shared with private apartments to the west)

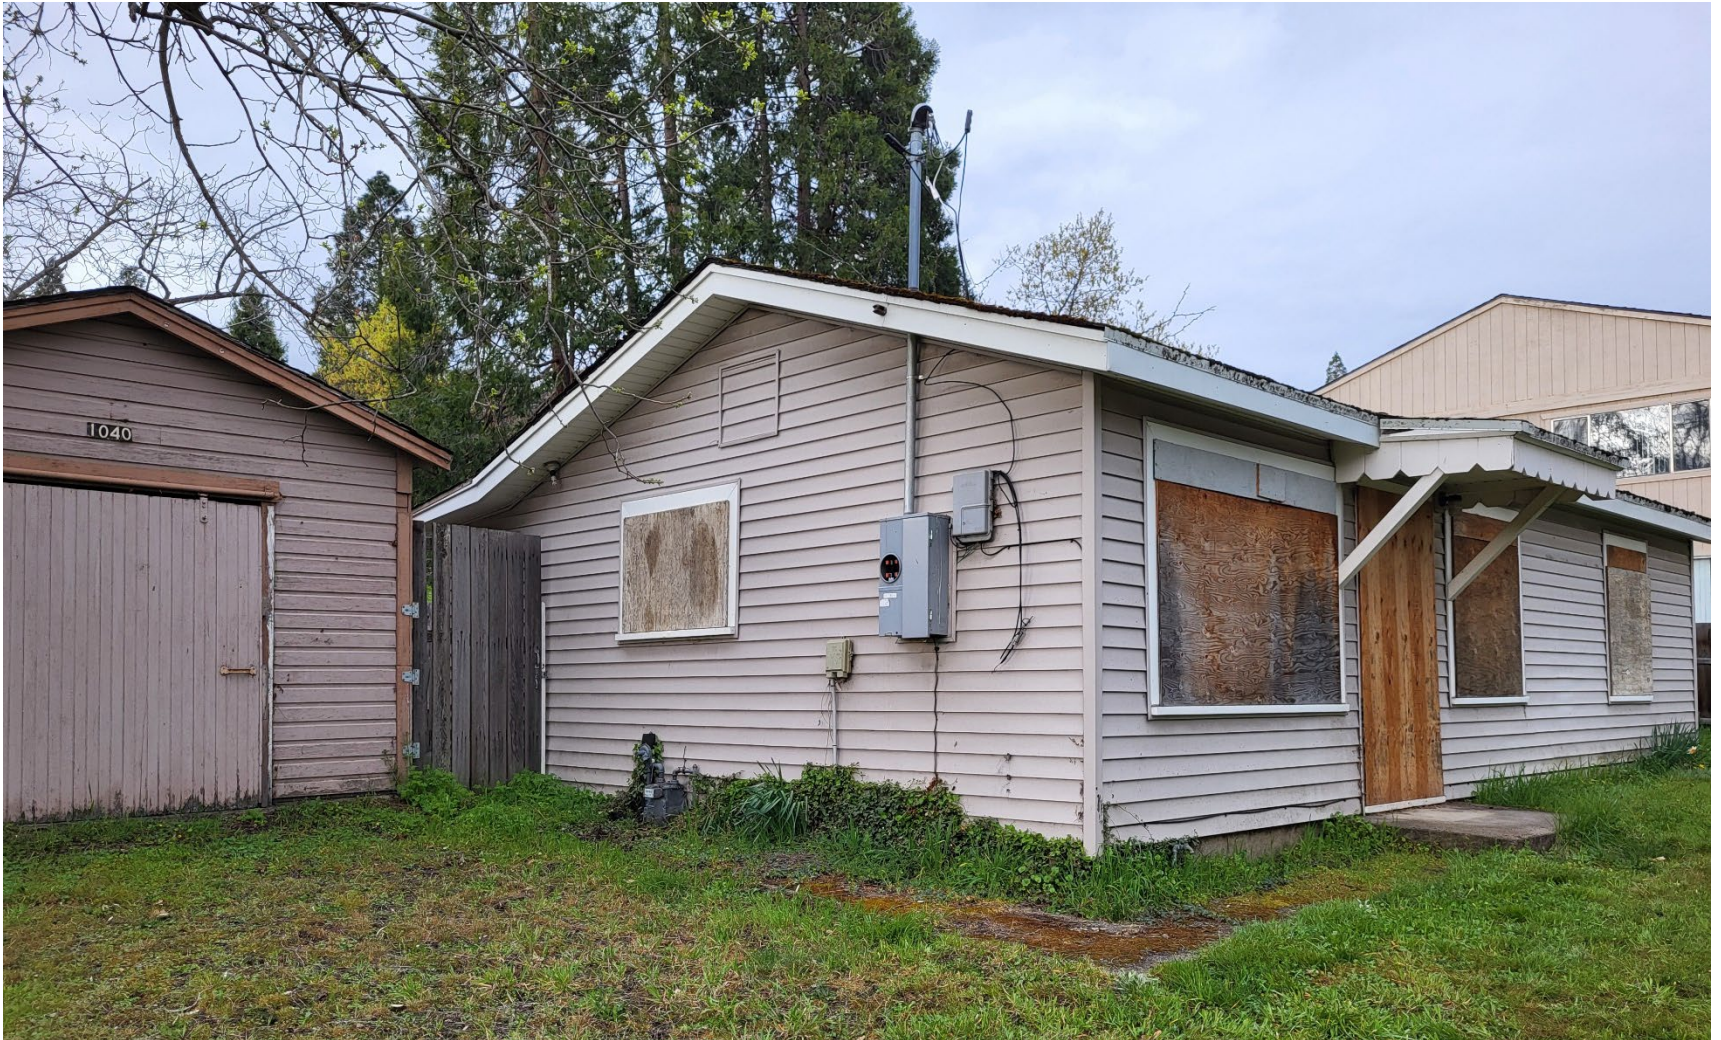
1040 Henry St

- Vinyl siding starting to deteriorate
- Suspected asbestos siding beneath vinyl siding
- Roof at end of life cycle, has leaked
- Bathroom ceiling collapsed on last inspection
- Garage is failing structurally
- Newer vinyl windows
- Partial kitchen remodel
- House not insulated
- No central HVAC, wall mounted gas furnace

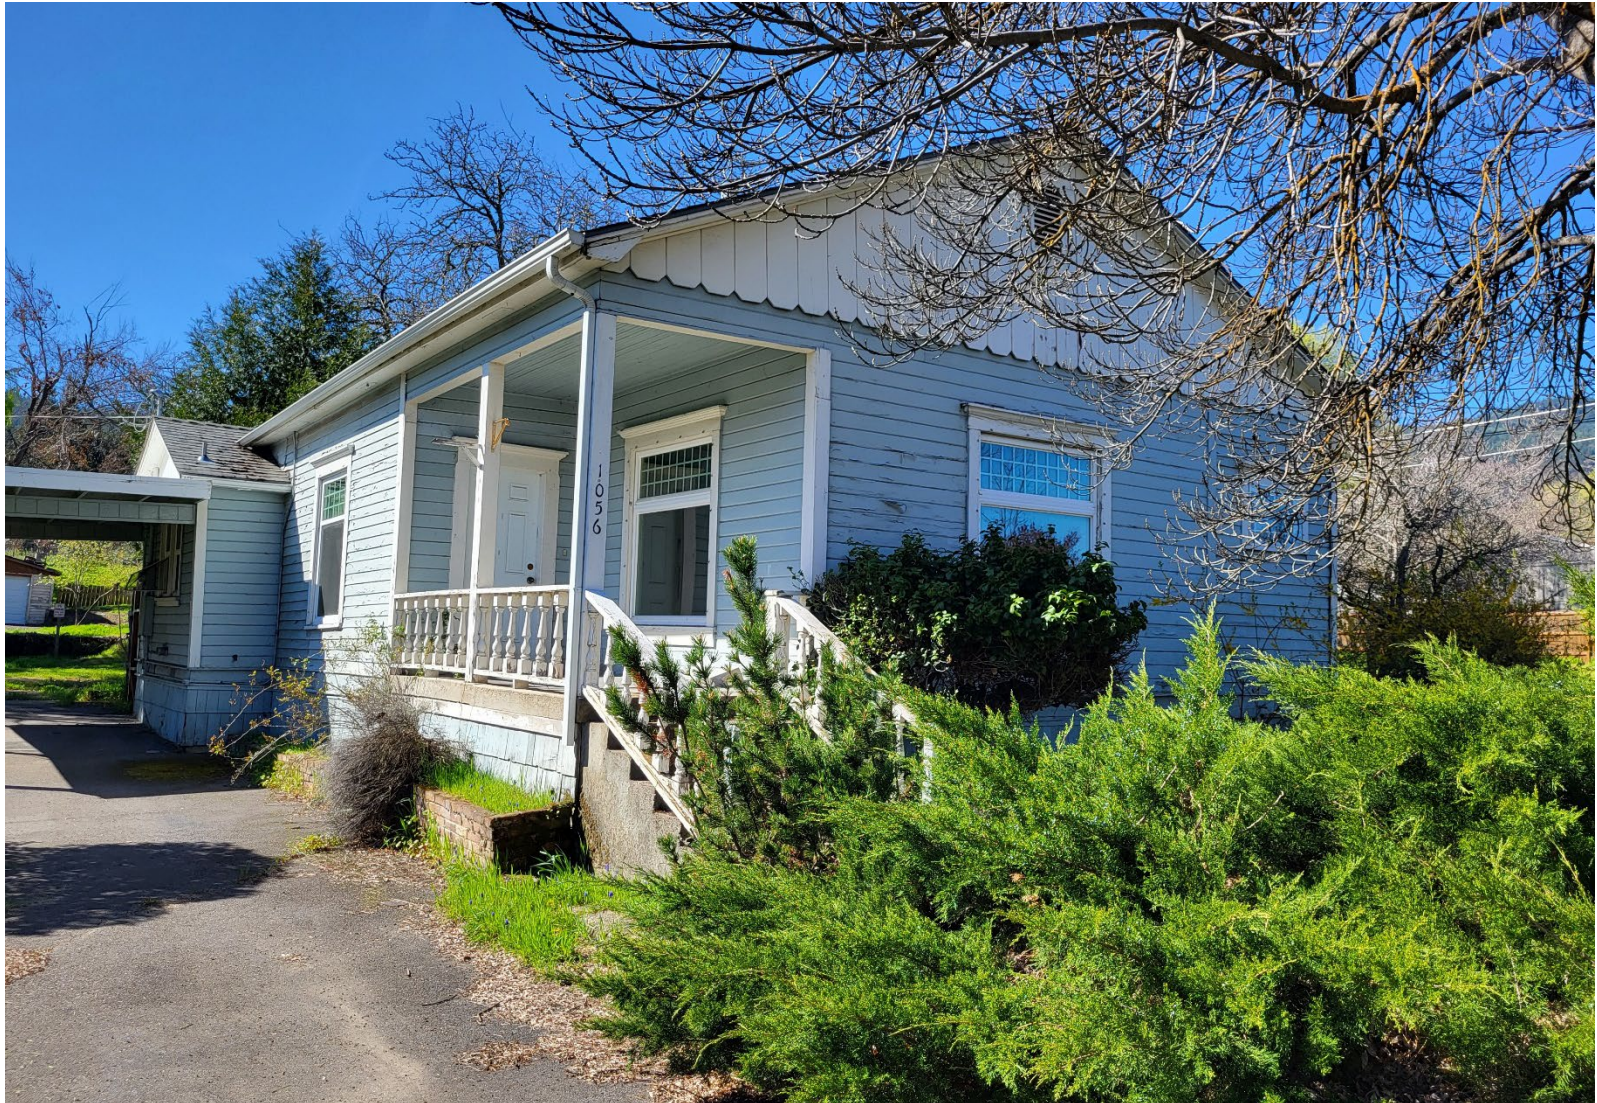
1056 Henry St

- Vandalism damage (windows)
- Asbestos siding
- Lead based paint flaking
- Foundation sinking (8" drop from corner to corner)
- Front porch separating & collapsing.
- Newer vinyl windows
- Was used as academic space in mid 2000's, IT infrastructure

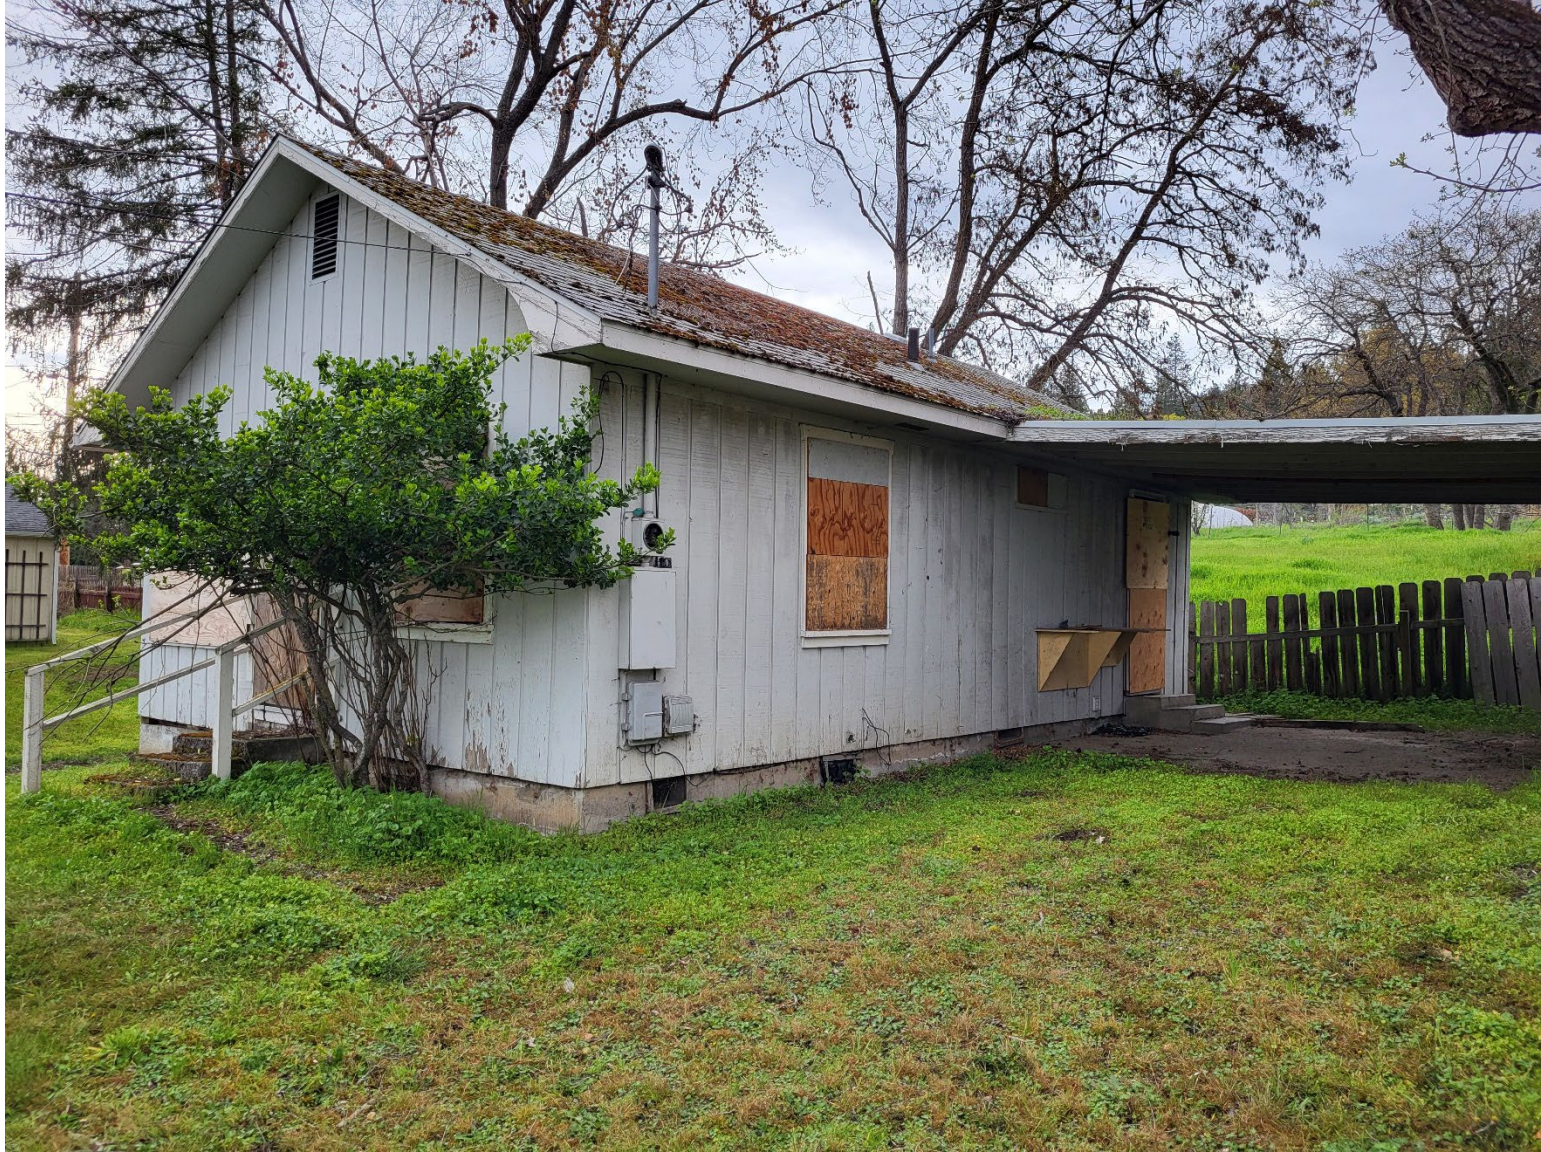
1058 Henry St

- Roof at end of life cycle.
- Carport not in good structural shape
- Fire damage in kitchen
- Smoke damage throughout house
- Rodent infestation
- No central HVAC, only a wall mounted gas furnace and a few baseboard heaters
- Foundation cracked in area of floor displacement
- Same tax lot as 1040 Henry St

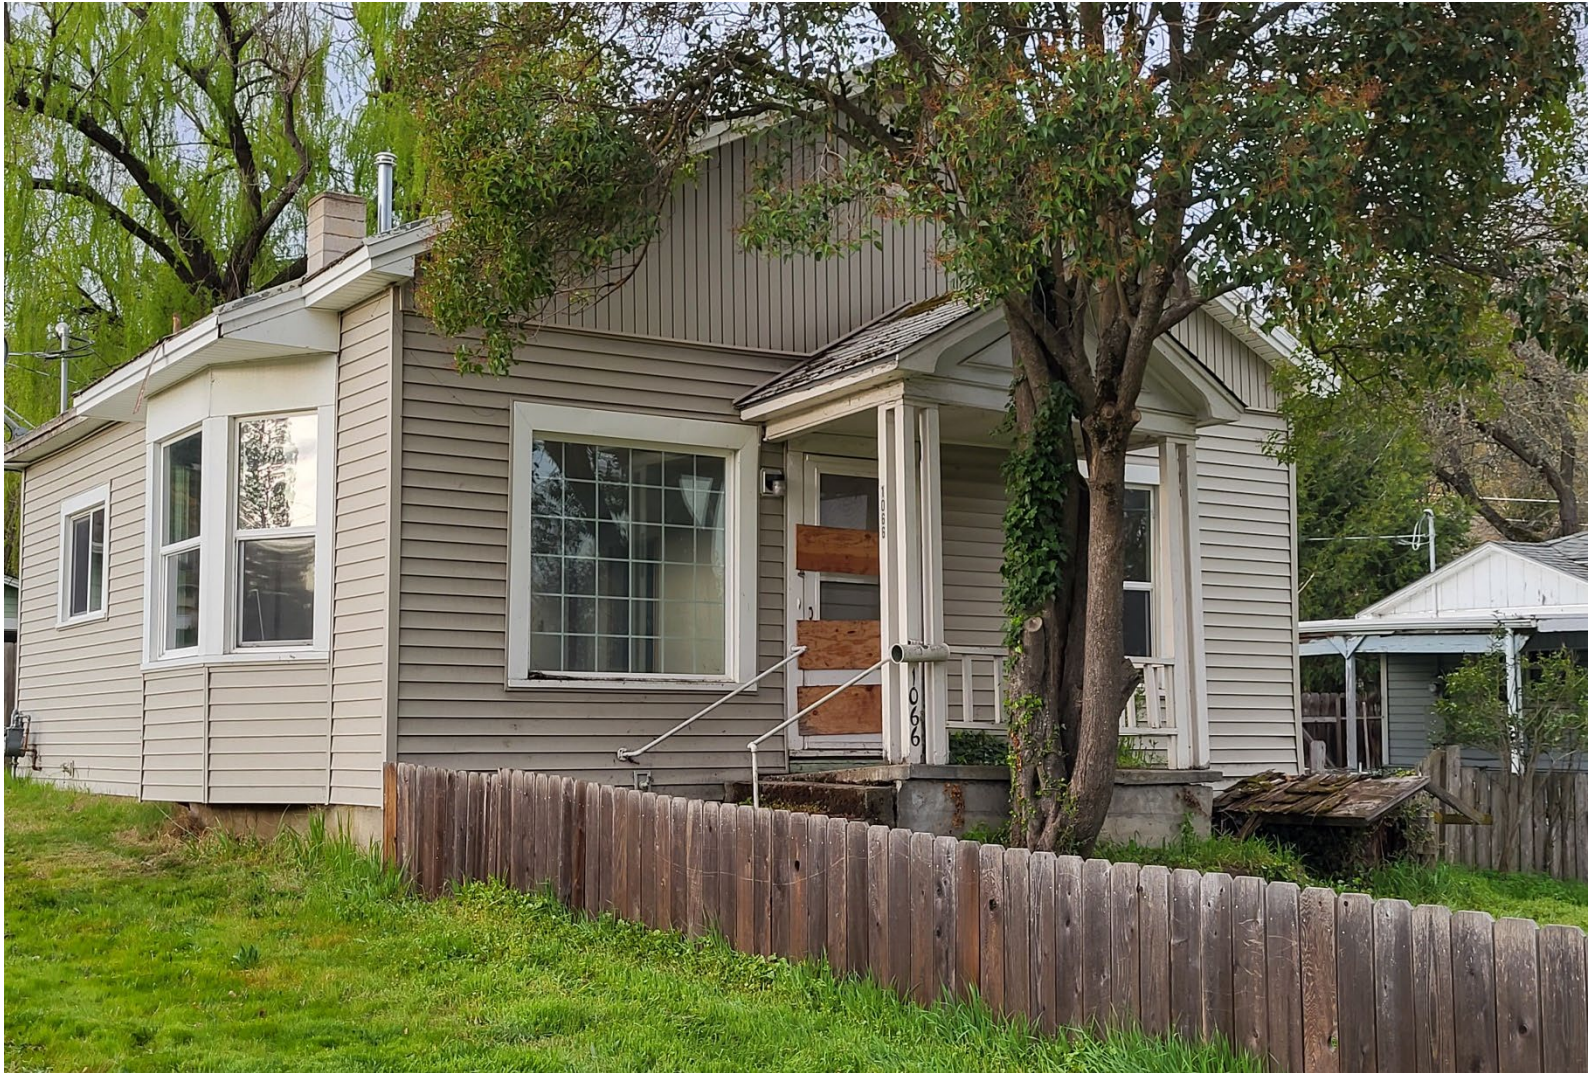
1066 Henry St

- Roof at end of life cycle
- No gutters
- Probable asbestos siding beneath deteriorating vinyl siding
- Front porch has lifted and separated from house due to trees
- Living room ceiling collapsed
- Interior of house “gutted” due to flood from pipe failure winter 2017
- Ceiling on NW corner is buckling due to foundation lifting
- Collapsed sewer line
